## Condition assessment of fire affected reinforced concrete shear wall building – A case study

**Abstract.** The post - fire investigation is conducted on a fire-affected reinforced concrete shear wall building to ascertain the level of its strength degradation due to the fire incident. Fire incident took place in a three-storey building made of reinforced concrete shear wall and roof with operating floors made of steel beams and chequered plates. The usage of the building is to handle explosives. Elevated temperature during the fire is estimated to be 350<sup>0</sup>C based on visual inspection. Destructive (core extraction) and non-destructive (rebound hammer and ultrasonic pulse velocity) tests are conducted to evaluate the concrete strength. X-ray diffraction (XRD) and Field Emission Scanning Electron Microscopy (FESEM) are used for analyzing micro structural changes of the concrete due to fire. Tests are conducted for concrete walls and roof slab on both burnt and unburnt locations. The analysis of test results reveals no significant degradation of the building after the fire which signifies that the structure can be used with full expectancy of performance for the remaining

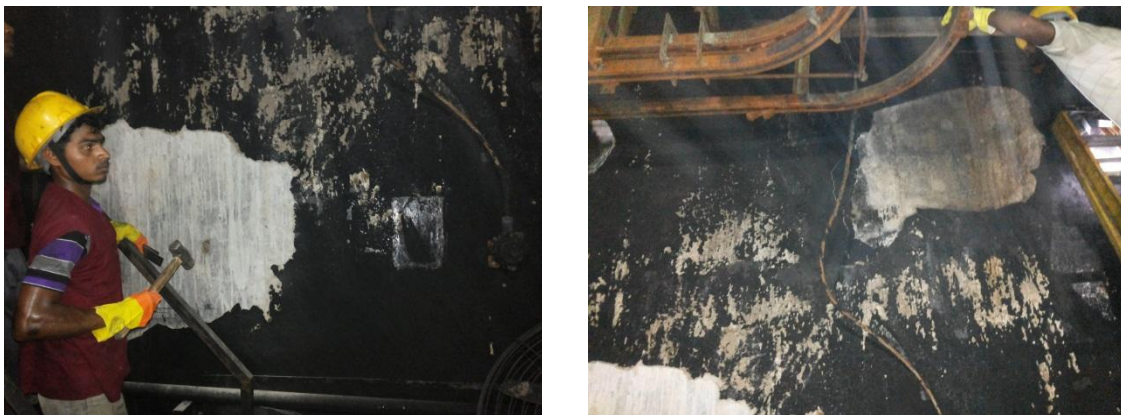
(b) The cement mortar plasters were found to be spalled off at certain places (Fig. 2). The surfaces of the structural components were found to be blackened due to the deposit of soot and smoke.

Fig. 2 Dark patches of burnt zones on the interior walls

Following the fire explosion in the second storey of this building, a visual investigation of the building has been conducted and the observations are documented. The dark textured burnt zones of the interior face of the building are shown in Fig. 2. The duration of the fire and possible maximum temperature was established based on apparent damage to the concrete (surface colour, cracking and spalling) and the field-combustible residues.

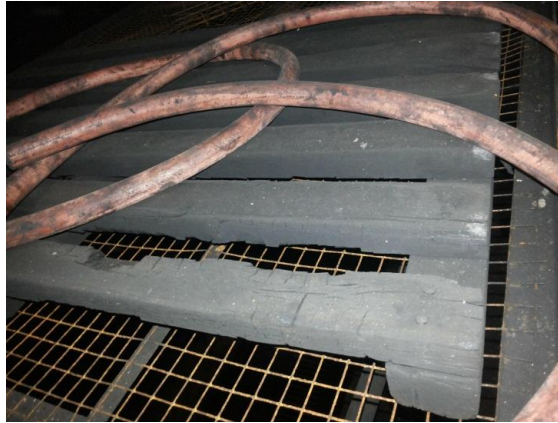
Fig. 3 Burnt wooden frame found in the proximity of the source of the fire

The possible maximum temperature due to the fire is correlated qualitatively from the field-combustible residues observed. For example, a burnt wooden frame was found in the proximity of the source of the fire as shown in Fig. 3. The cross section of the timber elements is approximately 50 mm × 25 mm and the element was exposed to fire in all four faces. The depth of the surface char layer formed was found to be negligible (5 mm or less) at the middle of the element. The charring of wood depends on the type of wood, duration of the fire and the temperature profile. It was informed that the fire lasted for at least four hours before being extinguished. Published literature (Frangin and Fontana 2003, Yudong and Drysdale 1992) has indicated that fire-point temperatures for different types of wood lie in the vicinity of 350-360°C and the surface combustion starts well before the initiation of flaming. Therefore, it can be concluded that surrounding temperature due to the fire has not gone beyond 350°C. Investigation of effect of temperature on electrical fittings in the room such as plastic covers of electrical wires, bulbs made of glass and others also support this fact.

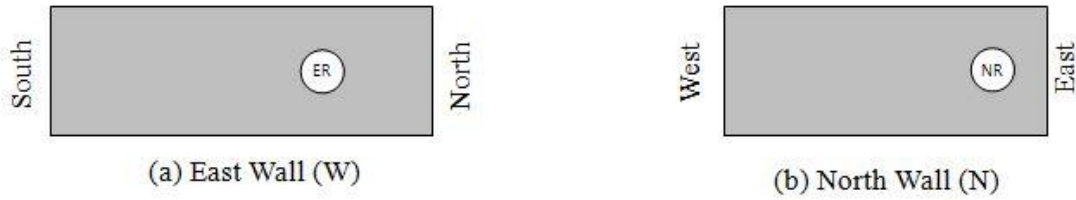
Fig. 5 Test points in unburnt areas in shear walls of ground storey

by fire) to represent the concrete of unburnt state. Figs. 5(a) and 5(b) present the selected reference points in, east (ER) and north (NR) walls respectively. Fig. 6 presents photograph of a typical test point after the test. Although the above test points for burnt and unburnt locations are considered for testing, in order to avoid the regions of maximum bending moment in roof slab, core samples were taken from the locations marked as RCA and RCB in Fig. 7.

The burnt specimens were taken from two locations, EA and EB (refer Fig. 4), and while the unburnt specimens were taken from ER and NR (refer Fig. 5). The XRD patterns of all the

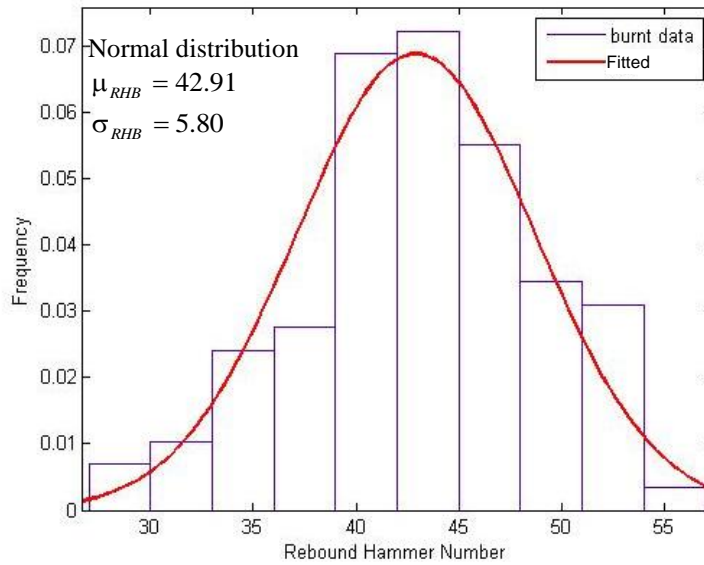
Fig. 8 Probability distribution and parameters fitted to RH data of the burnt area

As concrete is a heterogeneous material there is an inherent variability in its properties. In order to assess the relative changes in the properties of burnt and unburnt concrete considering this variability, probabilistic distributions of rebound numbers for both burnt and unburnt areas are fitted from the data of experimental values. Figs. 8 and 9 present the normal probability distributions for burnt and unburnt concrete respectively. The comparison of the rebound hammer numbers of burnt and unburnt concrete is plotted in Fig. 10. The trend of the probability distributions shows that the strength of burnt concrete is almost not affected due to fire in a mean sense.

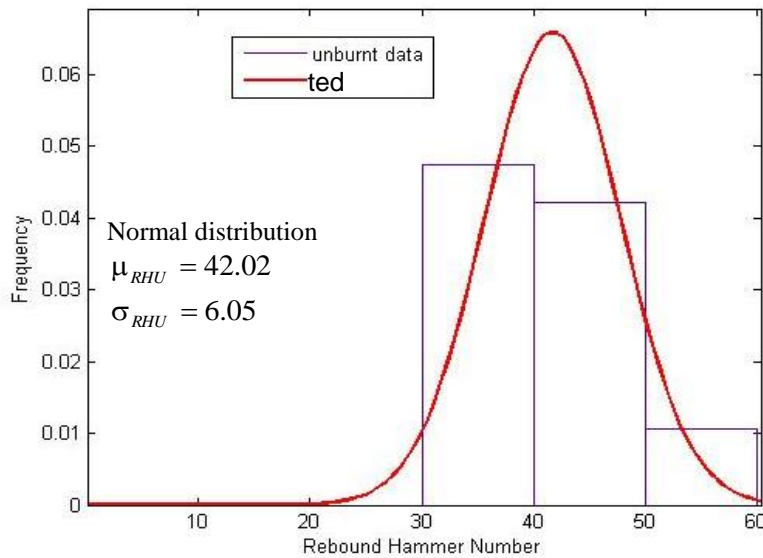
Fig. 9 Probability distribution and parameters fitted to RH data of unburnt area

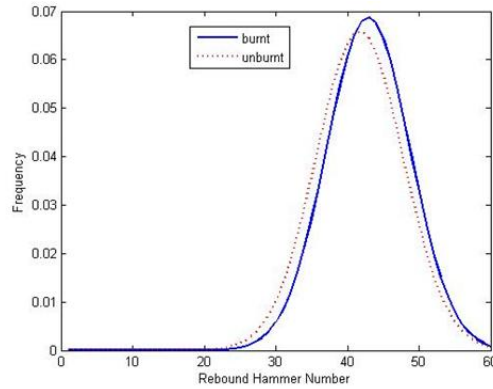
Fig. 10 Comparison of probability distributions for RH values

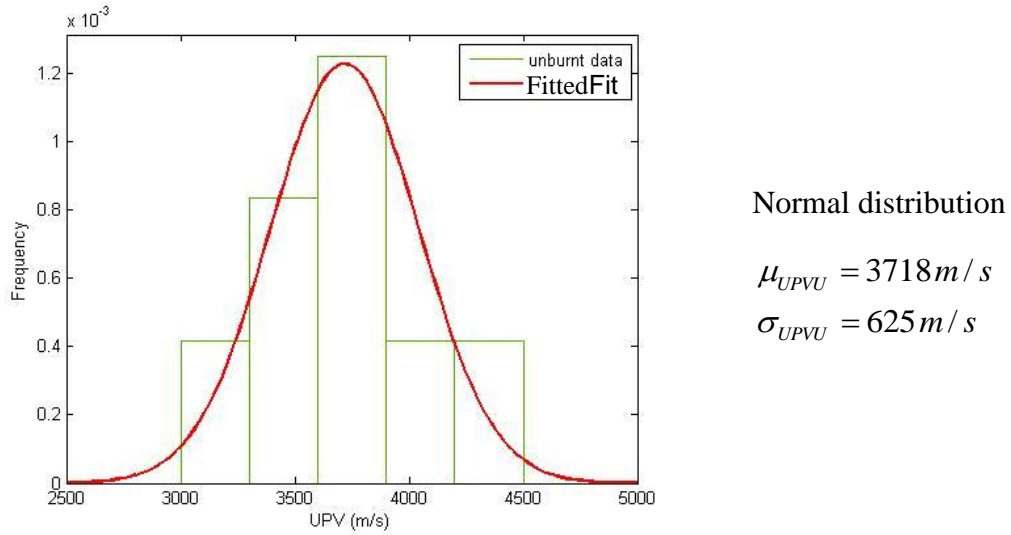
Fig. 12 Probability distribution and parameters fitted to UPV data of unburnt area

Probability distributions for ultrasonic pulse velocities of both burnt and unburnt concrete are fitted and presented in Figs. 11 and 12. Fig. 13 presents both these distributions together to

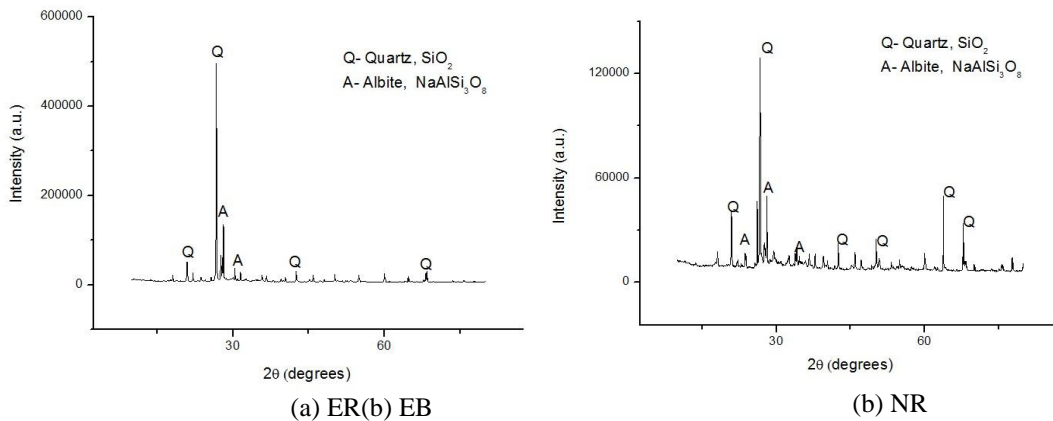
Fig. 15 XRD pattern of unburnt concrete specimens

specimens are shown in Figs. 14 and 15. The concrete specimens show amorphous phase with intensified peaks of quartz ( $\text{SiO}_2$ ) and albite ( $\text{NaAlSi}_3\text{O}_8$ ). The peaks of quartz and albite compounds are predominantly found in all the burnt and unburnt specimens. Quartz is a common mineral compound in concrete because of its presence in cement, fine and coarse aggregates. Similarly, albite is feldspar mineral present in the aggregates. It is observed from the XRD analysis that there is no significant variation between the chemical properties of burnt and unburnt concrete.
