# Seismic performance of South Nias traditional timber houses: A priority ranking based condition assessment

Mahmoud Sodangi and Zaheer Abbas Kazmi\*

**Keywords:** building defects; condition assessment; defect intensity index; earthquake; seismic shaking; traditional wooden house

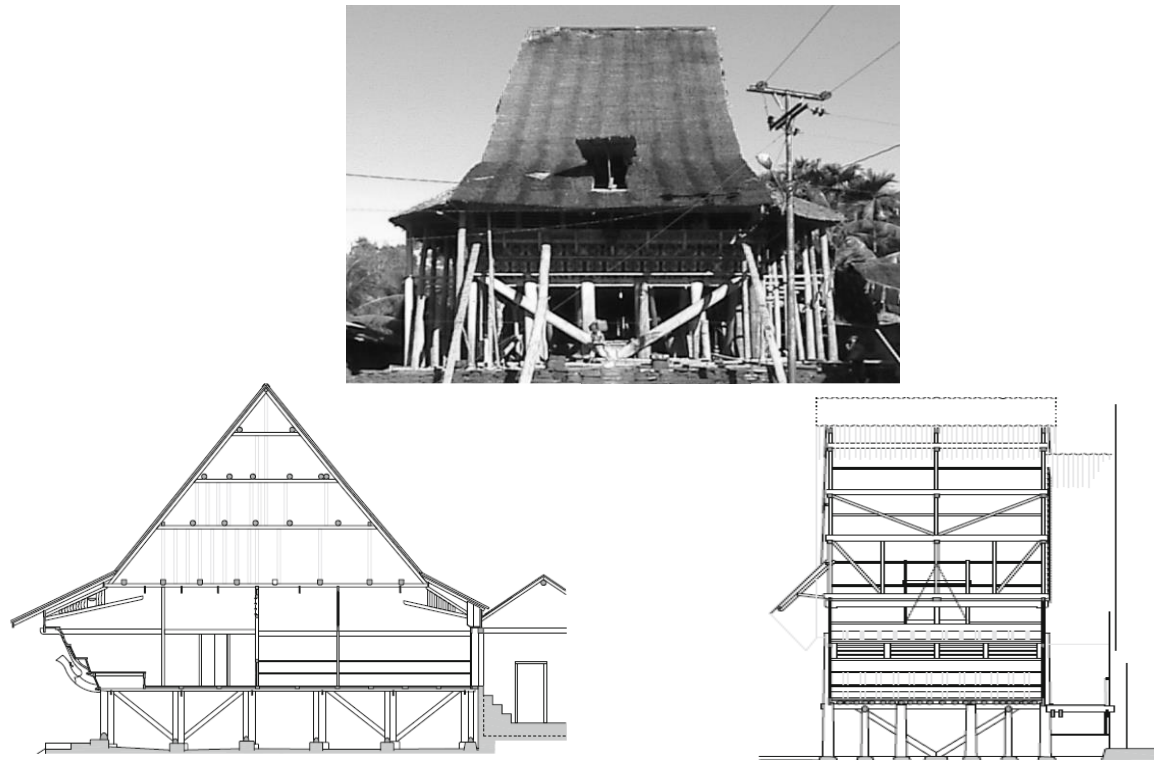
Fig. 4 Details of non-damaged “Building A” (a) three-dimensional view (b) cross section along the length (c) cross section along the width

Building A had for long been used as a private residence before its conversion to a tourist site (Fig. 4). Many parts of Building A remain the same since it was constructed, which makes it highly treasured cultural heritage. Some of the building’s details are provided in Table 1. The substructure of Building A comprises of sixty-two short pillars and forty cross pillars. The short pillars are 4m long and the diameter is about 48 cm, while the cross pillars are about 7m long, having a diameter of about 45 cm. The superstructure of the
