## The M6.4 Lefkada 2003, Greece, earthquake: dynamic response of a 3-storey R/C structure on soft soil

Christos Giarlelis\*, Despina Lekka, George Mylonakis and Dimitris L. Karabalis

*Department of Civil Engineering, University of Patras, 26504 Rio, Greece*

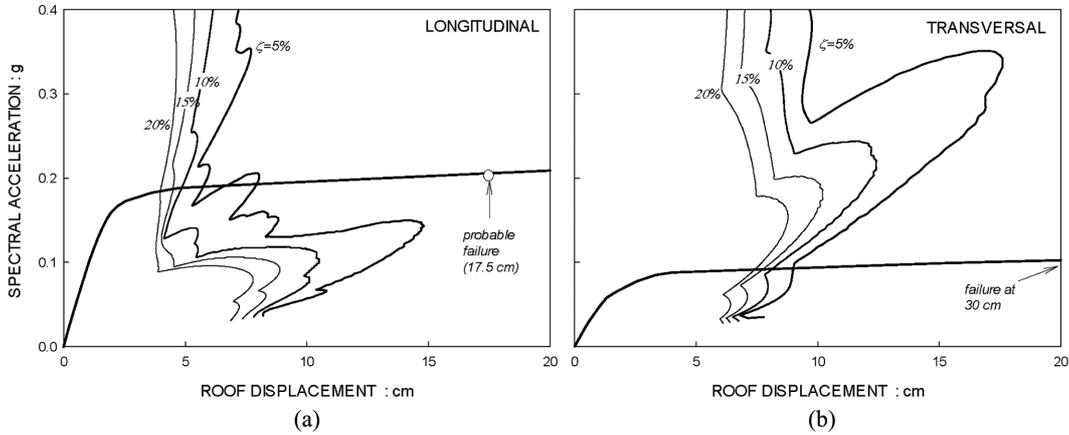
Fig. 13 Push-over diagrams and demand curves for the two orthogonal directions of the building

Regarding the “strong”  $L$  direction (Fig. 13(a)), the base shear corresponding to the yield point is  $V_{el} = 0.185W$  at a roof displacement of 1.9 cm. The failure point is located at  $V_{max} = 0.206W$ , at a roof displacement of 17.5 cm, providing a global overstrength  $q_{\omega} = 1.10$ . Plastic hinges start to develop at a roof displacement of approximately 4.8 cm at certain columns of the 1<sup>st</sup> and 2<sup>nd</sup> storey, including the ones that were actually damaged. Note that in most cases, formation of plastic hinges is related to reduction of the cross-section of the columns at the slab separating the 2<sup>nd</sup> and 3<sup>rd</sup> floors. As can be seen from Fig. 13(a), seismic demand in this direction is about 4 to 5 cm, which suggests permanent damage but no collapse.

With reference to the “weak”  $T$  direction, base shear corresponding to the elastic point is  $V_{el} = 0.086W$  at a roof displacement of 1.7 cm, whereas failure point is located at  $V_{max} = 0.11W$ , at a displacement of 30 cm. This results in a system ductility capacity,  $\mu^{(T)} = 30/1.7 = 19$  and an overstrength  $q_{\omega} = 1.3$ . Plastic hinges start to appear at a displacement of 15 cm. As can be derived from Fig. 13(b), seismic demand in this direction is 9 cm, thus obviously, at this point there is also permanent damage.

Apparently, along  $T$  direction, the structure employs only a small fraction (of the order of 15%) of its “design strength” of 0.11W, whereas along the  $L$  direction it uses over 50% of its design strength of 0.21W. Naturally, this difference would be reflected in deformations, hence the more pronounced damage observed in the longitudinal direction. This feature is also indicated in direct displacement analysis using the composite spectra of Fig. 13. Indeed, for conservative estimates of roof displacement demand at 5 cm and 7.5 cm, respectively, along the  $L$  and  $T$  directions, the associated global ductility demands are

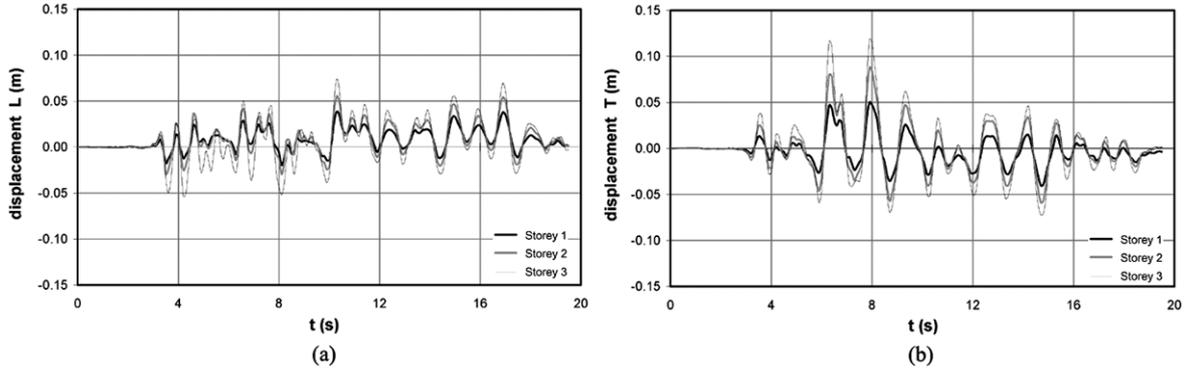
Fig. 14 Displacements at L and T direction of all floors, on top of damaged column 20, from the “soft set” of calculations (low member stiffness with SSI)

stiffness with SSI. In the longitudinal direction the range is from 0.062 m to 0.075 m respectively. Figs. 14 and 15 present the displacements for each storey of column 20 - one that was severely damaged - for the softest (low stiffness with SSI) and the stiffest (medium stiffness without SSI) set of calculations. Fig. 16 presents a comparison of displacements of the top of column 20 on second floor.
