# Ground response of a gob-side gateroad suffering mining-induced stress in an extra thick coal seam

**Abstract.** This paper presents an investigation of the ground response of a gob-side gateroad suffering mining stress induced by a 21 m-thick coal seam extraction. A field observation, including entry convergence and stress changes monitoring, was first conducted in the tailgate 8209. The observation results of entry convergence showed that, during the adjacent panel 8210 retreating period, the deformation of the gob-side gateroad experienced a continuous increase stage, subsequently, an accelerating increase stage, and finally, a slow increase stage. However, strong ground response, including roof bending deflection, rib extrusion and floor heave, occurred during the current panel 8209 retreating period, and the maximum floor heave reached 1530 mm. The stress changes within coal mass of the two ribs demonstrated that the gateroad was always located in the stress concentrated area, which responsible for the strong response of the tailgate 8209. Subsequently, a hydraulic fracture technique was proposed to pre-fracture the two hard roofs above the tailgate 8209, thus decreasing th

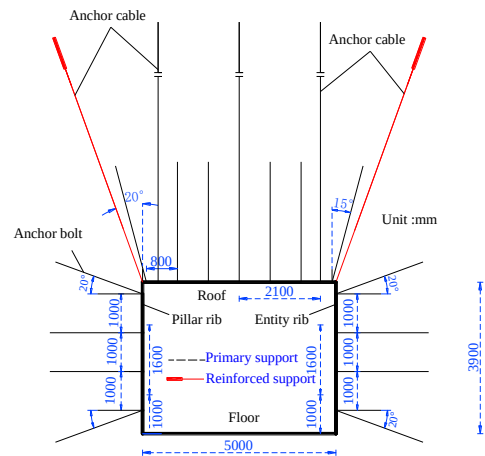
Fig. 3 Previous support scheme

The tailgate 8209 was 5.0 m wide and 3.9 m high, supported by bolts/cables, see Fig. 3. A 20 mm in diameter and 3100 mm long bolt was used in the roof support, and a 22 mm in diameter and 2400 mm long bolt was used in the two rib supports. The roof and ribs bolts were installed at a spacing of 800 mm × 900 mm and 1000 mm × 900 mm, respectively. The roof bolts were installed with steel mesh and a W-shaped steel strap for surface control. The rib support was installed with steel mesh and a steel channel for surface control. In addition, anchor cables were installed at the roof with a spacing of 2100 mm × 1800 mm. The cables were 21.8 mm in diameter and 8300 mm in length, and the cables were installed in a row on the same I-shaped steel beam.

**Stage I** Development of the tailgate 8209. In this stage, the gateroad excavation resulted in stress redistribution, which causes the coal and rock masses deformed and failed gradually. Field observations indicated that the entry convergence in this stage is limited and can be controlled, which can be attributed to a high strength support (see Fig. 3) and a relatively small stress disturbance.

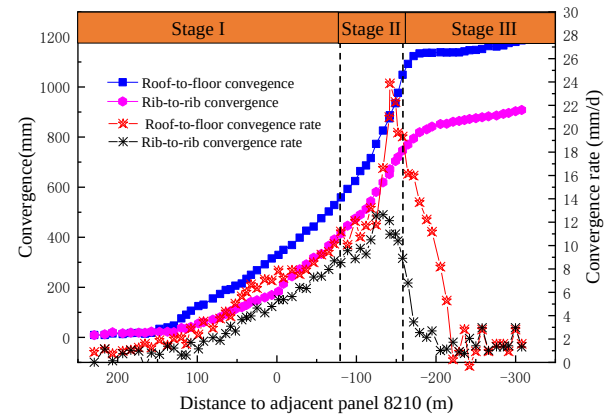
Fig. 5 Measured entry convergence of tailgate 8209 versus Panel 8210

Fig. 5 depicts the entry convergence and rate when the panel 8210 closed to the measurement station. The positive

numbers in the x-axis denote the station located in front of the panel 8210, while the negative numbers denote the station located behind of the panel 8210. In sum, based on the changes of entry convergence, the deformation and failure process of the gateroad can be divided into three stages: a continuous increase stage (Stage I), an accelerating increase stage (Stage II) and a slow increase stage (Stage III).

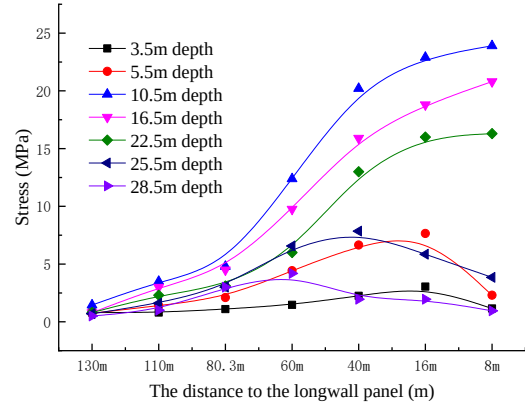
Fig. 8 illustrates the stress changes within the 30 m wide coal pillar during panel 8209 retreating. The x-axis refers to the relative distance between the panel 8209 and the meter-installed locations. For the stress meters at pillar depths of 3.5 m and 28.5 m, the stress reading kept a low value. For the stress at a pillar depth of 5.5 m, the stress first increased gradually, and then decreased significantly; when the meter was 16 m ahead of the mining panel, a maximum stress value of 7.65 MPa was reached. Similarly, the stress at a pillar depth of 25.5 m exhibited a similar changes tendency, and a maximum stress of 7.85 MPa was observed when it was 40 m ahead the mining panel. The above stress changes indicated that the coal mass at a coal pillar depth of 0–5.5 m and 25.5–30 m has been failed as the panel approached. For the stress changes at pillar depths of 10.5 m, 16.5 m and 22.5 m, the stress increase maintained a small rate when the panel retreating closer from 130 m to 60 m; then the

Fig. 8 Stress changes within the coal pillar during panel 8209 retreating

increasing rate increased significantly when the panel retreated further from 60 m to 8 m. It can be concluded that there existed a high stress zone at pillar depth of 10.5–22.5 m, indicating that the inner coal body of coal pillar had an enough bearing capacity to undertake the roof vertical loads.

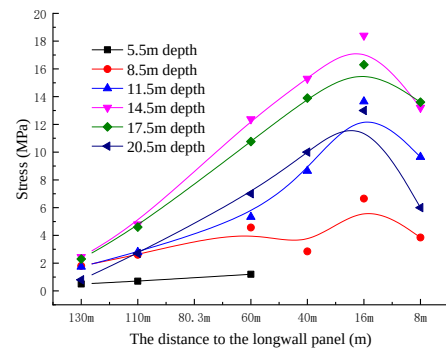
Fig. 9 Stress changes in panel rib at various depth versus the 8209 panel

Fig. 9 illustrates the stress changes within the panel rib during panel 8209 retreating. Note that the reading of the stress meter at a depth of 5.5 m was unavailable when it was 8–60 m ahead mining panel, and it can be predicted that they could have been damaged before the measurement. The stress reading exhibited linearly increased as the panel retreated closer to the station from 130 m to 16 m. With the further retreat of the panel from 16 m to 5 m, the stress decreased significantly. The maximum stress reading was observed when the panel was 16 m ahead of the meter-installed location. Noted that compared to the stress value at other depths, the most of stress at a depth of 8.5 m was generally low. This outcome indicated that coal mass on the panel rib side with a depth of 0–8.5 m has damaged to some degree.

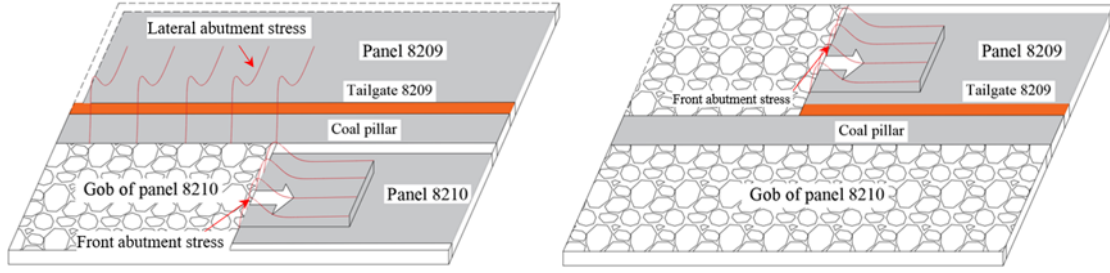
Fig. 10 Schematic plots of mining-induced stress at stage stage II and III

**Stage II** Retreat of the adjacent panel 8210. Due to the existing of hard massive stratum with a thickness of about 20 m (see Fig. 1), large-area overhangs strata emerged above the gob edge as the panel 8210 advanced. Thus, the stronger front abutment stress and the lateral abutment stress are created, see Fig. 10. According to the ground response of the tailgate 8209 and coal pillar width, it can be inferred that the tailgate 8209 is located at the lateral stress concentrated area. As a result, the entry convergence increases at a quickening pace in the field (see Fig. 4).

**Stage III** Retreat of the panel 8209. In this stage, the stress field balance was reactivated because of the retreat of panel 8210. Due to the large-area overhangs strata and the mining height nearly 21.1 m, the large impact loads induced by the fracture of the roof strata resulted in a large front abutment stress (Yavuz 2004), see Fig. 10. According to the numerical modelling results, the stress in the coal pillar and the panel rib reached 24.1 MPa and 18.3 MPa (Fig. 8 and 9), which was about 2.3 and 1.7 times the virgin stress, respectively. Affected by the higher stress, the gateroad suffered strong ground response (see Fig. 7).

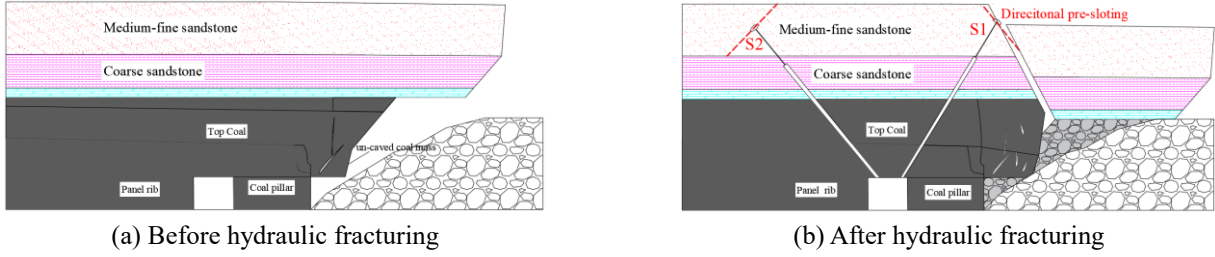
Fig. 11 Strata behaviors controlled with hydraulic fracture. (a) Before hydraulic fracturing and (b) After hydraulic fracturing

The thick and hard hanging roofs are responsible for the high mining stress and the strong response of the gob-side gateroads at stage *II* and *III*, see Fig. 11(a). Currently, hard roof treatment using the hydraulic fracturing method is an effective method to decrease the mining-induced high stress (Huang *et al.* 2017). Additionally, the directional initiation of hydraulic cracks can be achieved by pre-slotting in the borehole in the field, as a result, hydraulic fractures reorient in three-dimension space.

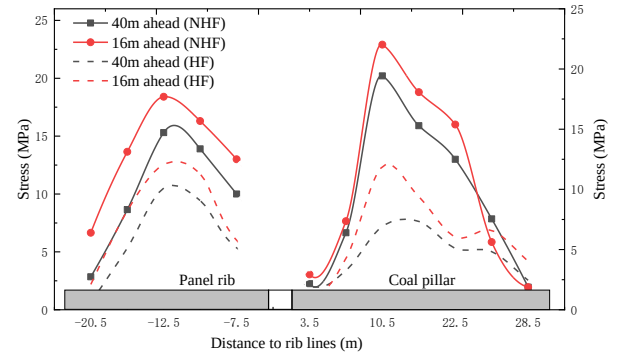
Fig. 13 Stress changes within two ribs in the scenarios of hydraulic fracturing (RS) and no hydraulic fracturing (NHF)

hydraulic fracturing, a field observation of stress changes and entry convergence was conducted in the test section. The detailed arrangement was similar to Fig. 4. Fig. 13 depicts the mining-induced stress in the gob-side gateroad after hydraulic fracturing scheme (HF). In comparing the conventional condition [e.g., no hydraulic fracturing (NHF)], the overall stress environment around the gob-side gateroad was improved to some degree. Although the stress distribution in the coal pillar and panel rib has similar tendency, but the peak stress in the coal pillar and panel rib decreased significantly.
