A correlation between moisture and compressive strength of a damaged 15-year-old rammed soil house

Abstract. Earthen structures have an excellent bioclimatic performance, but they are vulnerable against earthquakes. In order to investigate the edification process and costs, a full-scale rammed soil house was constructed in 2004. In 2016-2019, it was studied its seismic damage, durability and degradation process. During 2004-2016, the house presented a relatively good seismic performance ($M_w=5.6-6.4$). The damaged cover contributed in the fast deterioration of walls. In 2018 it was observed a partial collapse of one wall due to recent seismicity ($M_w=5.6-6.1$). The 15-year-old samples presented a reduced compressive strength (0.040 MPa) and a minimum moisture (1.38%). It is estimated that the existing house has approximately a remaining 20% of compressive strength with a degradation of about 5.4% (0.0109 MPa) per year (considering a time frame of 15 years) if compared to the new soil samples (0.2028 MPa, 3.52% of moisture). This correlation between moisture and compressive strength degradation was compared with the study of new soil samples at the same construction site and comp

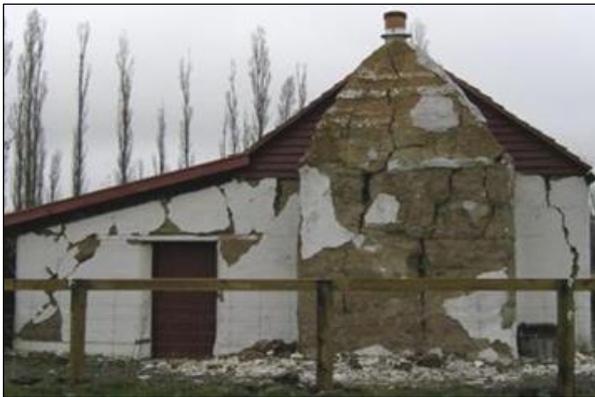
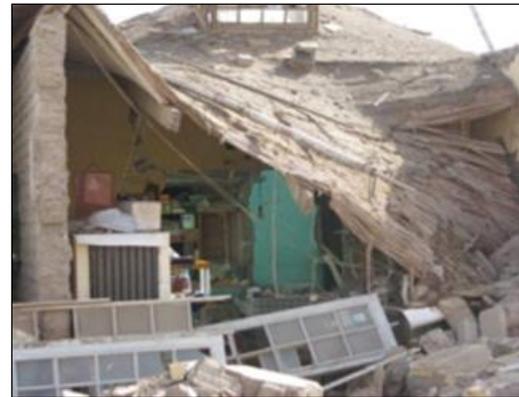
Fig. 3 Typical observed seismic failure modes of earthen housing

(a) In-plane failure of rammed soil walls (Morris *et al.* 2010) (b) Cover collapse by out-of-plane failure of adobe walls (Varum *et al.* 2014)

perpendicular walls with a vertical distribution of cracks along the structural element. The lack of integrity has more impact under seismic loading due to the fact that the shaking induces a detachment between elements and complex brittle failure mechanisms in-plane and out-of-plane that may end in a partial or global collapse of the building with human casualties (Fig. 3). The overall behavior of earthen structures (i.e., adobe and rammed soil) is mainly governed by the low tensile strength, which agrees with the observed behavior (i.e., quasi-brittle) in vulnerable unreinforced masonry structures (e.g., Lourenço and Pina-Henriques 2006, Milani 2011a, b, Preciado *et al.* 2015a, b, Preciado and Sperbeck 2019), but even more brittle due to its inefficient mechanical properties. These aspects have also an impact on the poor seismic performance of rammed soil housing, in addition to the heavy mass of this material, brittleness, erosion and lack of connectivity among walls. The seismic behavior and failure mechanisms of this material depend on the nonlinear behavior since low horizontal seismic loading, anisotropy of the material and pre-existing cracking/damage. Another effect that complicates the behavior and failure is the loading direction and the anisotropy of the material which may induce different cracking propagation on walls in the plane, out-of-plane and combinations due to the material characteristics, aspect ratio of walls, mass, vertical loading, openings and so on. The in-plane failure is mainly represented by diagonal shear cracks at walls (Fig. 3(a)) and at the perimeter of openings (e.g., windows or doors) and by vertical cracking at the intersection of walls as aforementioned by the lack of structural integrity.

Conversely, the out-of-plane mode may occur by the rapid formation of a horizontal crack at the wall's base, followed by a global collapse or roof failure into the interior part due to supports vibration by the induced perpendicular loading (Fig. 3(b)). The construction of earthen structures represents interesting benefits from the economical and sustainable point of view against conventional materials such as masonry and concrete that deserve to be investigated in detail from different approaches to understand the main components that determine its very high seismic vulnerability. This knowledge in behavior and failure under different loading conditions (i.e., uniaxial compression, shear, bending and so on) would allow to propose suitable retrofitting proposals able to avoid human casualties in case of intermediate to strong EQs. The study of this brittle material is a topic of great importance and very active research by the scientific community in terms of construction techniques, behavior and failure modes (e.g., Morris *et al.* 2010, Taghiloha 2013, Silva *et al.* 2014a, Preciado *et al.* 2017, Preciado and Santos 2019) to identify strengthening techniques with sustainable materials as soil injection, natural fibers and stabilization cements (e.g., Islam 2002, Burroughs 2008, Silva *et al.* 2014b, Varum *et al.* 2014). The stabilization of rammed soil increases its strength, durability and elastic properties as Young's modulus (e.g., Bahar *et al.* 2004).

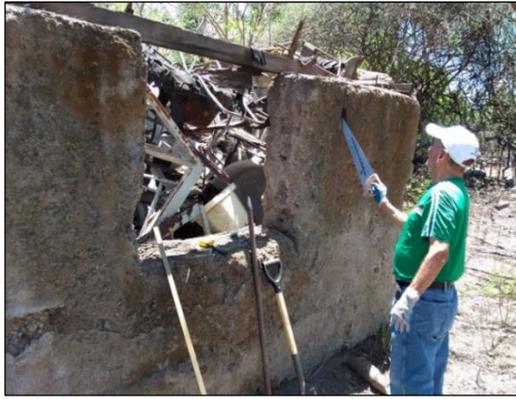
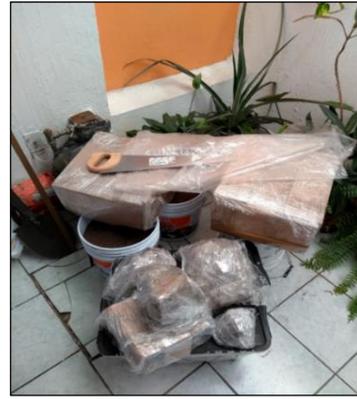
Fig. 10 Rammed soil walls sampling extraction and transportation

In late summer 2018, it was extracted several coarse

samples of approximately 25x25x25 cm from some walls including the collapsed ones with cutting tools (Fig. 10(a)) to investigate the impact of aging on the strength degradation of the existing rammed soil walls exposed to extreme weathering and zero-maintenance. The sampling extraction was difficult due to the presence of large stones inside the walls with average diameters ranging from 2.5-10 cm. The coarse samples were packaged (Fig. 10(b)) and transported to ITESO University in Guadalajara, Jalisco (180 km from Colima City) in order to be subjected under different investigations such as uniaxial compressive tests with a universal test machine (UTM) (Fig. 11(a)) and its correlation to the water content, materials composition and failure mechanisms under extreme loading. From the coarse wall samples (Fig. 10b), it was extracted more segments and were carved until reaching cubes with final average dimensions of 6.5x7.5x8.5 cm (Table 4) capped with a slight layer of gypsum (see Figs. 11(b) and 11(c)) for a uniform loading transmission with the UTM. The observed failure mechanisms in the extracted samples M1-M5 under uniaxial compression tests are shown in Fig. 12, where it is worth noting in all cases, the typical crushing behavior and a rapid propagation of vertical and semi-diagonal distribution of cracks (Fig. 12(a)-12(c)). Some of the samples only shown several vertical/diagonal cracks (Fig. 12(a)), other ones just a large vertical crack (Fig. 12(b)) and the rest, a combination of cracks (Fig. 12(c)). The stress-strain curves and envelope of the existing wall samples M1-M5 under uniaxial compression tests are illustrated in Fig. 13(a). It is worth noting that the five samples presented a

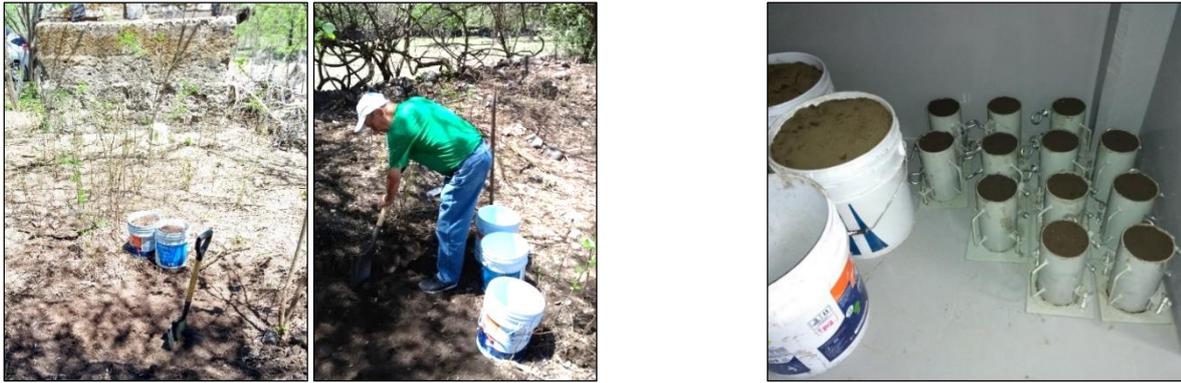
Fig. 14 Extracted soil samples and new specimens

In order to compare the degraded uniaxial compressive strength of the existing rammed earth walls, new soil specimens were fabricated. For achieving the last, it was extracted different soil samples from the same construction site where the self-constructed house is located (Fig. 14(a)) and fabricated in laboratory 12 cylinders of h= 20 cm and d= 10 cm (see Fig. 14(b)).

The soil mix presented a granulometry of 33.34% of fines (clay and silt), 44.84% of sand and 21.82% of gravel with a density of 1809 kg/m³ (a dried density of 1136 kg/m³). These physical soil properties are in agreement with the properties reported in literature for good quality soils for rammed earth structures (see Table 1). Moreover, these properties are also similar to the used earth in the construction of the house, due to the soil was extracted from the same site. In addition of the soil classification, it was subjected to a detailed sieving analysis (i.e., particle size distribution) to determine the quantitative properties of the

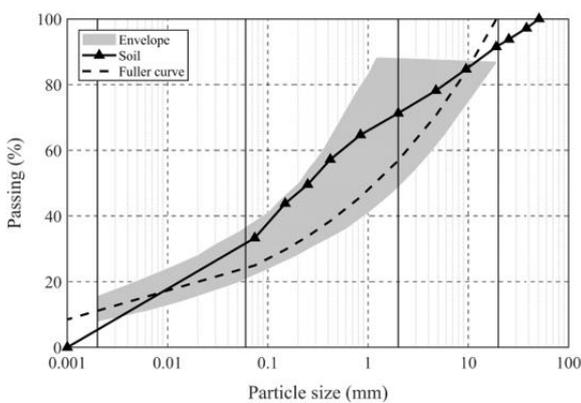
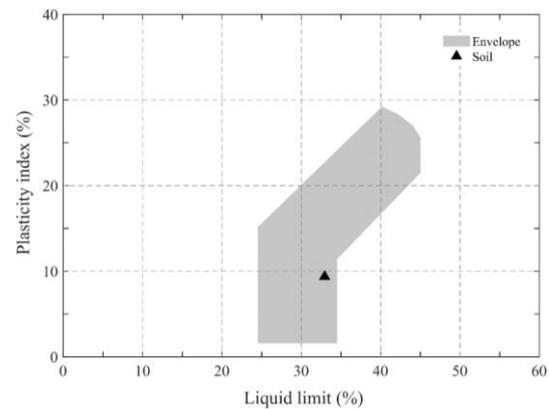
Fig. 15 Quantitative properties of the extracted soil samples based on granulometry tests

new extracted samples. This analysis allowed to determine the Fuller curve as shown in Fig. 15(a).

This methodology is used in highway engineering in the design of pavements. Moreover, if the soil is located close enough of the Fuller curve or inside the envelope of suitable soils for rammed earth proposed by Houben and Guillaud (2008), then it might be considered as a soil with acceptable characteristics. It is worth noting in Fig. 15(a), that the soil under study fits well inside the envelope, even when it is slightly different than the Fuller curve. Another great advantage of this strategy, is that it allows the possibility of

correcting the soil by the addition of fines, sand or gravel in terms of percentage with the sieving methodology. Moreover, with the use of the Atterberg limits, it is possible to determine other important quantitative soil properties such as the consistency or plasticity limits: the soil under study exhibited a liquid limit (LL) of 32.94%, a plastic limit (PL) of 23.56% and a plasticity index (PI) of 9.38% (LL-PL) (see the black triangle in Fig. 15(b)). The PI of 9.38% is representative of soils with a medium plasticity (7-17%). These soil properties are also in agreement with the reported limits and indexes in the relevant literature

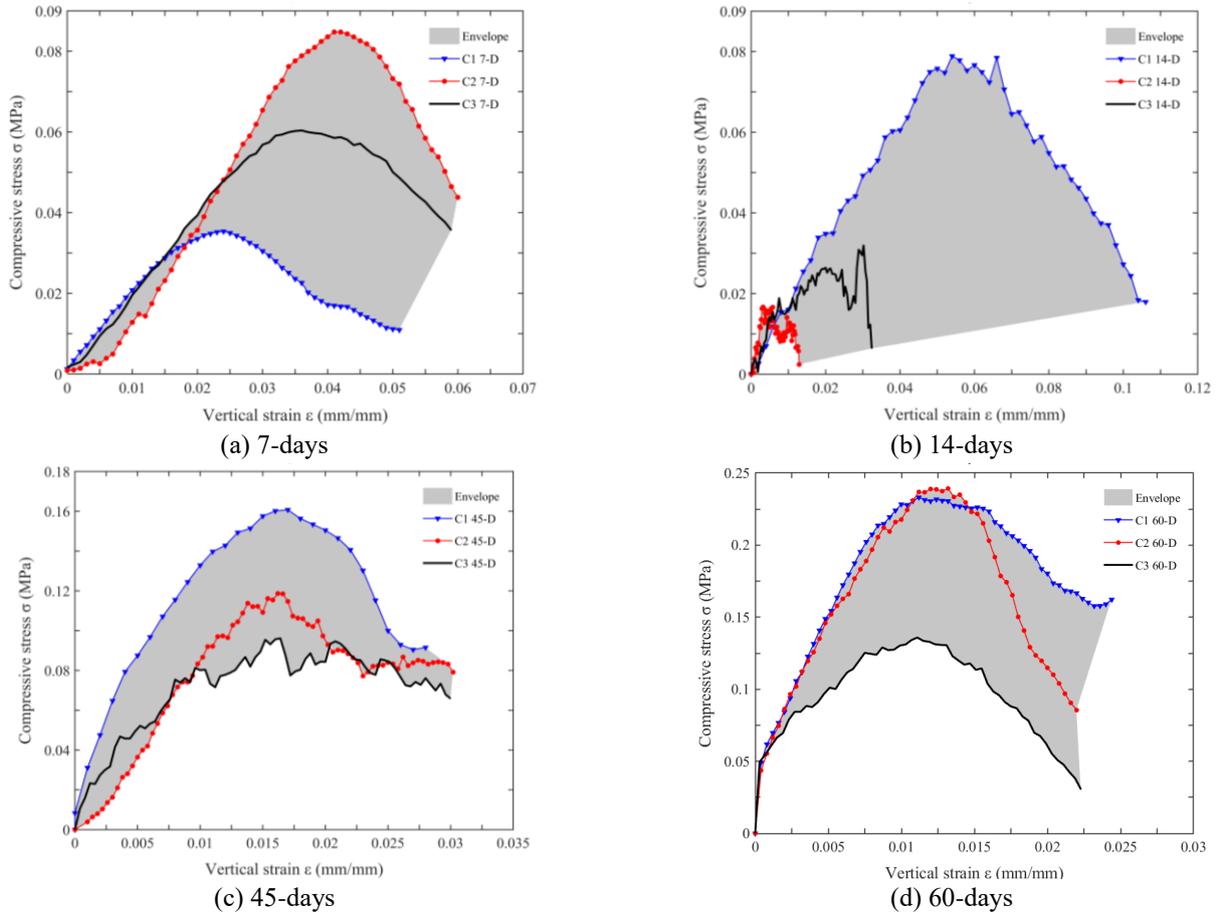
Fig. 17 Stress-strain curves of the new specimens *C* under compression at different ages

Fig. 17 illustrates the stress-strain curves of all samples under uniaxial compression and Table 5 the summary of physical and mechanical properties. The stress-strain curves of 7-days (Fig. 17(a)) and 14-days (Fig. 17(b)) samples presented a similar mean compressive strength (0.043-0.060 MPa). The strength increasing was observed in the 45-days specimens (Fig. 17(c)) with a mean ultimate stress of approximately two times higher than the observed in the 7-14-days ones (0.125 MPa). Furthermore, the 60-days samples (Fig. 17(d)) presented a mean compressive strength (0.203 MPa) of about 1.6 times higher than the 45-days ones, and in average, four times higher than the 7 and 14-days samples. The summary of physical and mechanical properties of the new soil specimens under uniaxial compression is shown in Table 5. The correlation between compressive strength and water content of the existing 15-year-old samples M1-M5 and the new soil cylinders *C* is illustrated in Fig. 13(b). It is worth noting that the 15-year-old samples presented an approximated mean compressive strength (0.040 MPa, 1.38% moisture) to that of the

exhibited by the 7-14-days samples (0.043-0.060 MPa, 17.61-18.54% moisture), but with a great difference regarding water content percentage. Moreover, the specimens tested at 60 days approximately presented 2.5 times more water content than the measured in the 15-year-old samples, but a substantial increasing in the mean ultimate strength (0.203 MPa, 3.52% moisture) of about 508% (five times higher).

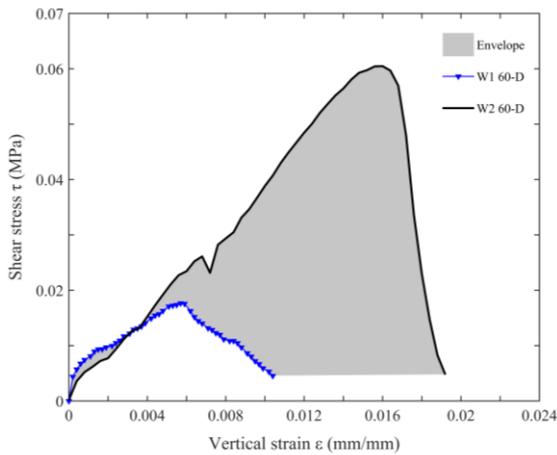
Fig. 19 Stress-strain curves of the two wallettes under diagonal shear (W1 unmolded on day 60 and W2 unmolded on day two)
