Correlation of damage and analysis of R/C building: Experience from the 1995 Kobe earthquake

Taizo Matsumori† and Shunsuke Otani‡

Abstract. During the 1995 Hyogoken-Nanbu Earthquake, a reinforced concrete building, called *Jeunesse Rokko*, suffered intermediate damage by forming a beam-yielding (weak-beam strong-column) mechanism, which has been regarded as the most desirable earthquake resisting mechanism throughout the world. High cost to repair damage at many beam ends and poor appearance expected after the repair work made the owner decide to tear down the building. Nonlinear earthquake response analyses were conducted to simulate the behavior of the building during the earthquake. The influence of non-structural members was considered in the analysis. The calculated results were compared with the observed damage, especially the location of yield hinges and compression failure of spandrel beams, and the degree of cracking in columns and in column-girder connections.

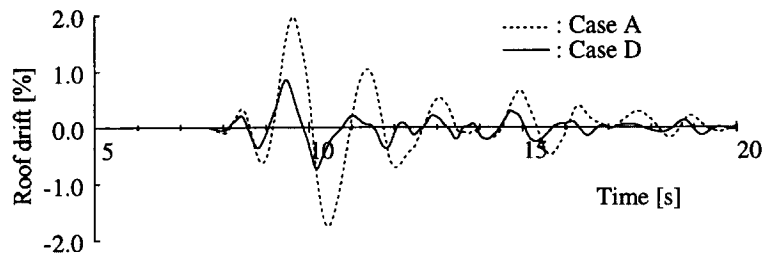
Fig. 10 Response roof drifts

The two analytical models exhibited a significant difference in the roof-drift waveforms (Fig. 10). The roof drift of Case A exceeded 2.0 percent, while the roof drift of Case D reached only 0.85 percent. The non-structural walls (Case D) added significant stiffness to the structure. Displacement response was dramatically reduced by the non-structural walls.

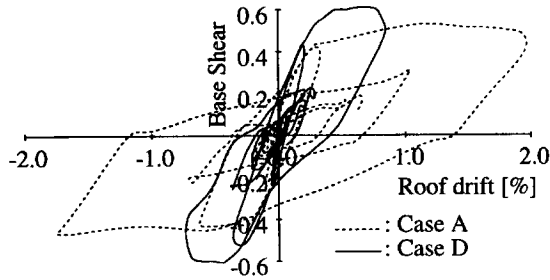
Fig. 11 Base shear-roof drift relations

The base shear coefficient-roof drift relations of Cases A and D are compared in Fig. 11. The pure frame model (Case A) developed yielding at base shear coefficient of 0.4, and large inelastic deformation took place in the large amplitude oscillation.

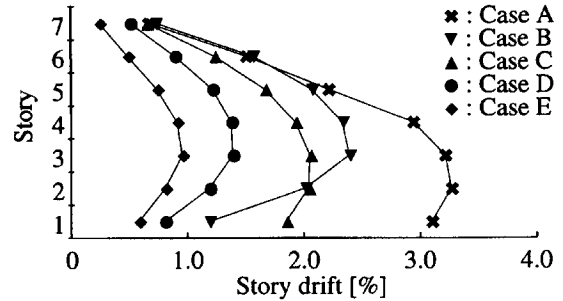
Fig. 12 Maximum response story drifts

Maximum story drifts (inter-story displacement divided by the inter-story height) are shown in Fig. 12. Largest story drift was calculated for Case A; story drifts over 3.0% were calculated from 1st to 4th stories. The modeling of non-structural walls in the 1st story in Case B, the story drift was reduced much from Case A (pure frame model) especially in 1st

and 2nd stories; maximum story drifts were reduced to 38% and 62% of Case A in 1st and 2nd stories, respectively. By including the elevator core walls in the analysis of Case C, story drifts were reduced at 1st to 4th stories; maximum story drifts were reduced to 60 to 66% of Case A in these stories. If both 1st-story non-structural walls and the elevator core walls were considered in Case D, story drifts were significantly reduced to 26% and approximately 40% of Case A in the 1st story and from 2nd to 4th stories, respectively. The effect of monolithic non-structural walls is significant on the deformation response of a building.

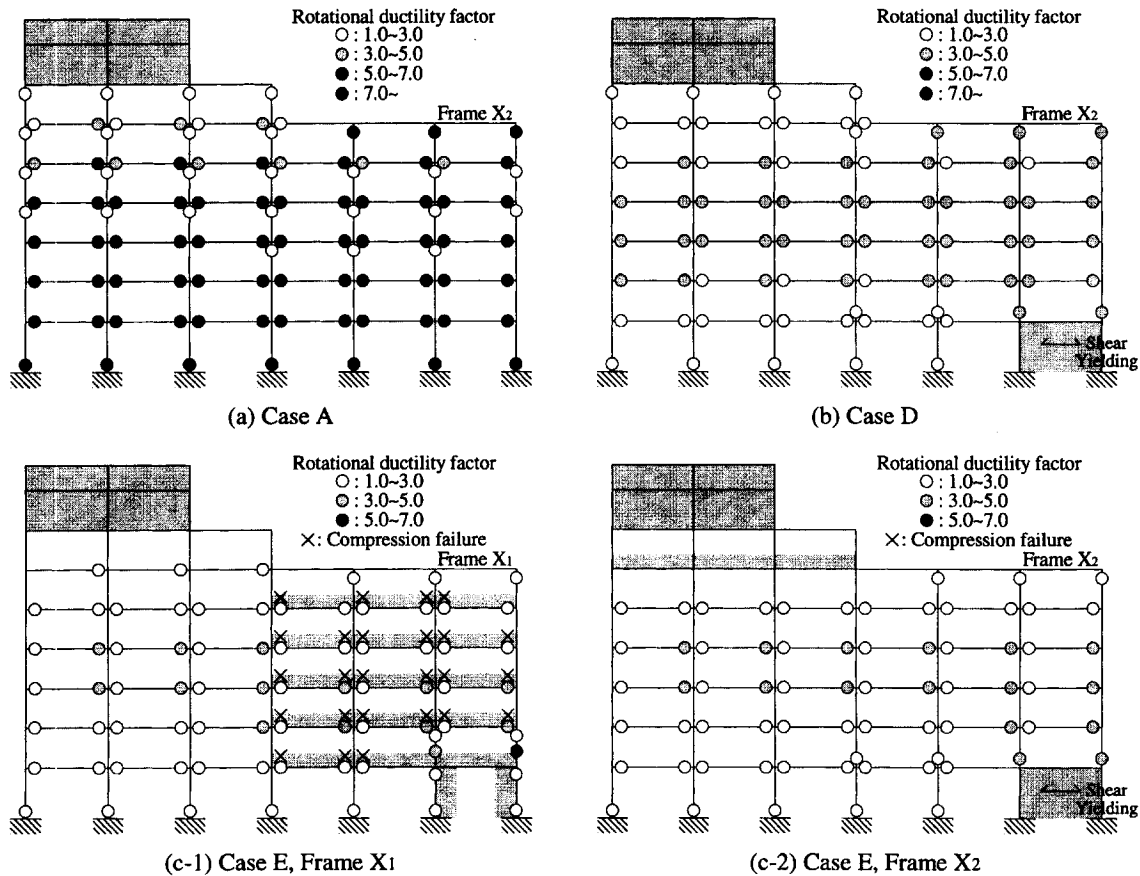
Fig. 13 Location of yield hinges and compression failure of spandrels

The formation of yield hinges is compared for Cases A, D and E in Fig. 13; the location of compression failure in spandrel beams is also indicated for Case E. In all three cases, the structure developed flexural yielding at all girder ends from 2nd to 7th floors, at the base of 1st-story columns and at the top of 7th-story columns. In Cases B and D with non-structural walls in the 1st story, yield hinges were also calculated at the base of 2nd-story columns; the non-structural walls in the 1st story yielded in shear. In Cases C and D with elevator core walls, the walls yielded in flexure at the base of 1st and 2nd stories.

When the spandrel beams were considered in Case E, girder-end ductility demand was reduced to 1.6 to 2.5 in the positive bending at the ends of 2nd to 6th-floor girders; the response was large enough to cause failure of the spandrels. Bending moment in the 7th-floor girders was, however, less than the flexural yielding moment in the positive bending. Flexural yielding was calculated at the base of 2nd-story columns at Y_6 and Y_7 in frame X_1 .

The locations of flexural yielding and the amplitude of girder-end ductility demand agreed favorably with the observed damage for Case D, including the degree of flexural crushing of concrete at girder ends and at 2nd-story column bases, the extent of flexural cracking in the 1st-story walls around the elevator core, and slipping shear failure of the non-structural walls in the 1st story. Crushing of spandrels observed from 2nd to 6th floors, but not at the 7th floor, could be explained by the analysis of Case E. In the following discussion, the simulation of damage by Cases D and E are considered.
