Smart Structures and Systems, Vol. 15, No. 3 (2015) 523-541 DOI: http://dx.doi.org/10.12989/sss.2015.15.3.523

# Effects of local structural damage in a steel truss bridge on internal dynamic coupling and modal damping

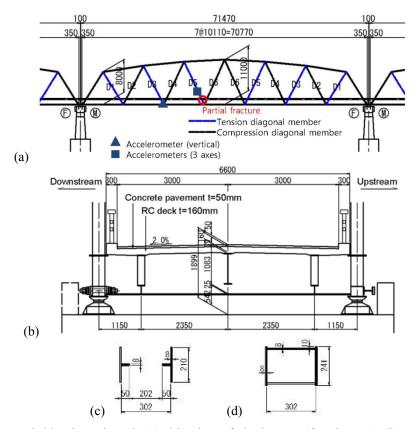
The bridge investigated was a bridge over a river for road traffic in-service from 1965. The bridge consisted of five separated spans, each of which was a simply supported Warren truss with a span length of 70.77 m and a width of 6.0 m (Fig. 1). The tension diagonal members had an H-section and the compression diagonal members had a box section, as shown in Figs. 1(c) and 1(d). There were eight or nine oval openings in the web of each tension diagonal members, except those at the ends of each span, for the reduction of the weight of steel (Fig. 2(a)).

During a visual inspection in July 2007 after 42-year service, partial fractures were found near the edge of gusset plate at either top or bottom end of longest tension diagonal members (D5 in Fig. 1), among which one in the fourth span resulted in loss of the half of its H-shaped cross section (Fig. 2(a)). In August 2007, as an emergency measure, additional steel plates with the same thickness as the member (i.e., 8 mm) were fixed by high strength bolts to cover both sides of the flanges and web for a length of about 1.5 m from the end of the members (Fig. 2(b)).

Fig. 1 Steel truss bridge investigated: (a) side view of single span (fourth span), (b) cross section of bridge, (c) cross section of tension diagonal member, (d) cross section of compression diagonal member. Unit [mm].

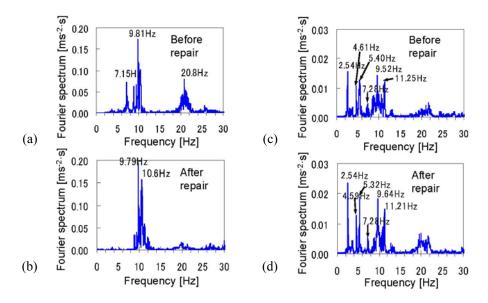
Fig. 3 shows examples of Fourier spectra of accelerations measured for a speed of 40 km/h with highest signal to noise ratio. The Fourier spectra were calculated with 8192 point FFT which resulted in the frequency resolution of 0.0244 Hz. As observed in Figs. 3(a) and (b), the dominant frequencies in the in-plane vibration of D5 were different before and after the repair. On the other hand, there were no clear changes in the vertical vibration of the lower chord (Figs. 3(c) and 3(d)).

Fig. 3 Fourier spectra of measured acceleration. With dump truck running at 40 km/h. (a) D5, in plane, before repair, (b) D5, in-plane, after repair, (c) lower chord at quarter span, vertical, before repair, (d) lower chord at quarter span, vertical, after repair

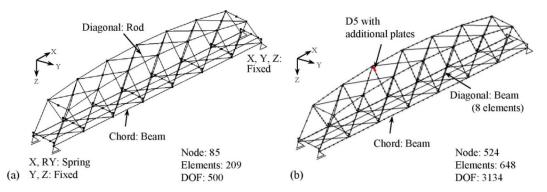
Fig. 4 (a) Basic model and (b) model with diagonal vibration and with additional plates

In addition, another model in consideration of additional steel plates at D5l for repair described above was developed. The effect of local structural change on the modal properties of the bridge could be understood theoretically from this model. Table 2 compares the properties of cross section of D5 in healthy and repaired conditions. These properties were assigned to the top element in D5l to model the increases in stiffness and mass by the additional plates (Fig. 4(b)).
