Seismic vulnerability and preservation of historical masonry monumental structures

Abstract. Seismic damage and vulnerability of five historical masonry structures surveyed after the 1999 Kocaeli and Duzce, Turkey earthquakes are discussed in this paper. The structures are located in two neighboring cities that have been struck by five very large ($M_s \geq 7.0$) earthquakes during the 20th century alone. Older masonry mosques with arches and domes and their masonry minarets (slender towers) were among the most affected structures in this highly seismic region. While some of the religious and historical structures had virtually no damage, most structures suffered significant damage or collapsed. In the city of Bolu, for example, approximately 600-year-old Imaret, 500-year-old Kadi, 250-year-old Sarachane, and 100-year-old Yildirim Bayezid mosques suffered substantial structural damage after the 1999 earthquakes. Another historical mosque surveyed in Duzce partially collapsed. Most common factors contributing to deterioration of historical structures are also presented. Furthermore, a brief overview of issues associated with analysis and modeling of historical masonry structures is

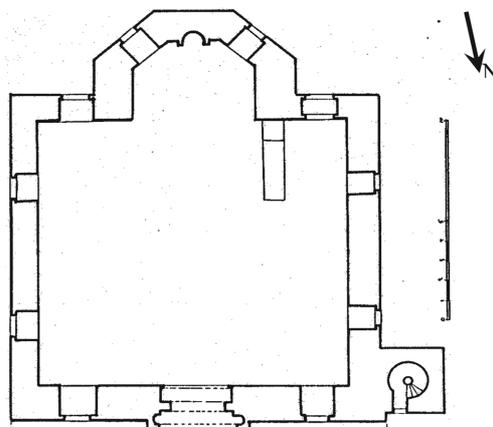
Fig. 3 Kadi mosque floor plan

The main prayer hall of the Kadi mosque has a square floor plan with approximately 13 m inside dimensions. As shown in Fig. 3, walls on the south side of the structure form a five-sided polygon,

more like an apse in older church structures. Typical thickness of the stone masonry walls is approximately 1.5 m. The square base of the circular masonry minaret in the northwest corner was constructed integrally with the mosque walls. It was reported that the original structure had a dome, however the current structure has a timber roof (Kenthaber 2006, Archive 2006).

Several cracks formed through the mortar and stone blocks on the sides and above the main entrance door during the earthquakes (Fig. 5). The stone masonry minaret collapsed right above its base because the minaret base was integral with minaret walls (Fig. 3) and was quite stiff compared to the cylindrical minaret body. The Kadi mosque recently went through a retrofit program. The walls were repaired and a new minaret with a more modern appearance was constructed (Fig. 6(b)).
