Rehabilitation of normal and self-compacted steel fiber reinforced concrete corbels via basalt fiber

Abstract. This paper investigates the behavior of normal and self-compacted steel fiber reinforced concrete (SCC-SFRC) corbels rehabilitated by Basalt Fiber Mesh (BFM) and Basalt Fiber Fabric (BFF) for the first time in literature. The research objective is to study the effectiveness of BFM and BFF in the rehabilitation of damaged reinforced concrete corbels with and without epoxy injection. The experimental program includes two types of concrete: normal concrete, and self-compacted concrete. For normal concrete, 12 corbels were rehabilitated by BFM without injection epoxy in cracks, with two values of compressive strength, three ratios of steel fiber (SF), and two values of shear span. For self-compacted concrete, 48 corbels were rehabilitated with different parameters where 12 corbels were rehabilitated by BFM with and without epoxy injection, 18 heated corbels with three different high-temperature level were rehabilitated by repairing cracks only by epoxy injection, and 18 heated corbels with three different high-temperature level were rehabilitated by repairing cracks by epoxy

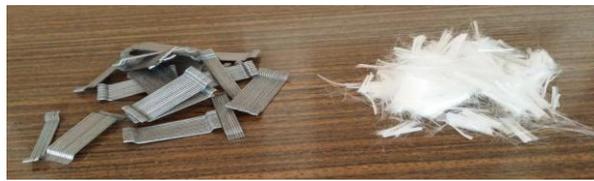
Fig. 2 Steel and polypropylene fibers

- For the second group and second part of group one, the steel fibers used were hooked end of 30 mm length, of 0.75 mm diameter, and 40 aspect ratio; with 3 different percentages (0%, 0.5%, and 1.0% steel fiber). Polypropylene fibers (PP) of 12 mm length, 0.2 mm diameter, 0.91 g/cm³ density, and 450 N/mm² tensile strength with a percentage of 0.1% of concrete volume were added in the second group. Fig. 2 shows the steel and polypropylene fibers used in this study.

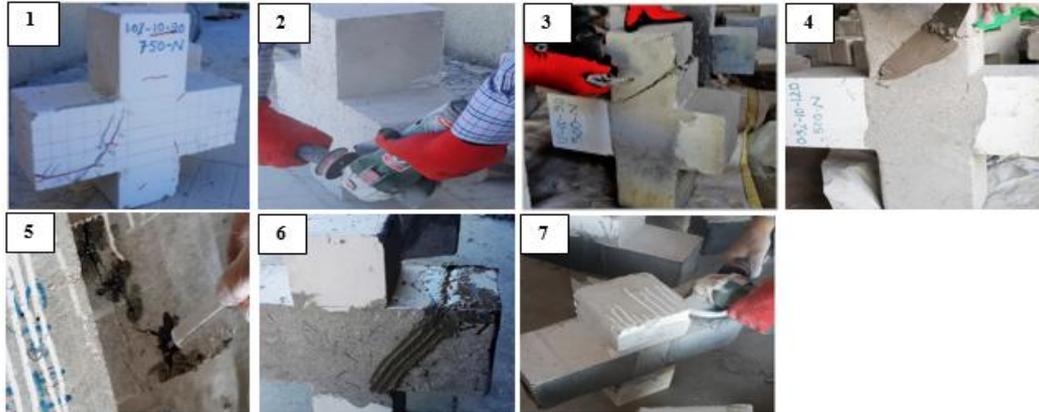
Fig. 4 Configuration steps of the preparation surface and injection of crack repairing epoxy

was used to level the bottom surface of the all corbel beams as shown in step 7 in Fig. 4, in order to provide the appropriate setup on the supports of the testing machine.

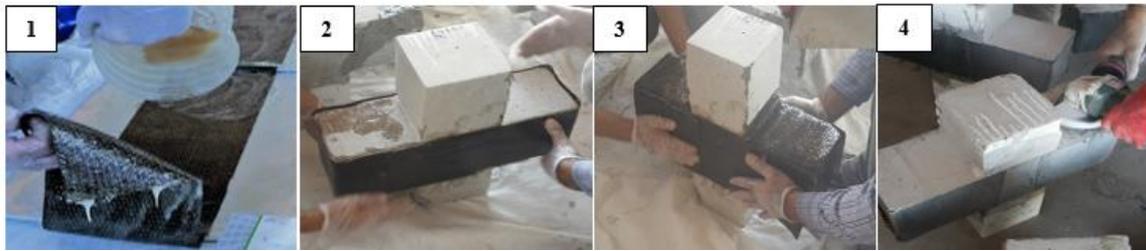
Fig. 5 Configuration steps of bonding surface and applying the BFF with epoxy

The second part of group two of corbels was strengthened with BFF in addition to repairing of cracks. The wet lay-up method was followed to replace the strips of BFF which is recommended by ACI 440.2R-08 (ACI 440 2008). Three strips of the BFF were prepared in specific dimensions that are compatible with the corbel dimensions. The components of crack repairing epoxy (epoxy hardener and resin) were mixed by an electric drill machine according to datasheet of the repairing epoxy. Then the BFF was saturated with the low viscosity epoxy for gluing process. The saturated BFF were glued bi-directionally onto the corbels to achieve better resistance to the combination of vertical and horizontal stresses. Therefore, one layer of the fabric was placed parallel to the corbel axis, and the other layer was wrapped transversally to the corbel surface. Afterward, a trowel was used to eliminate air voids and to achieve perfect adhesion between the fabric and corbel surface. At last, grinder machine was used again for leveling bottom surface of corbels to provide successful simultaneous load transfer mechanism up to both of the supports. The steps of strengthening with BFF are illustrated in Fig. 5.

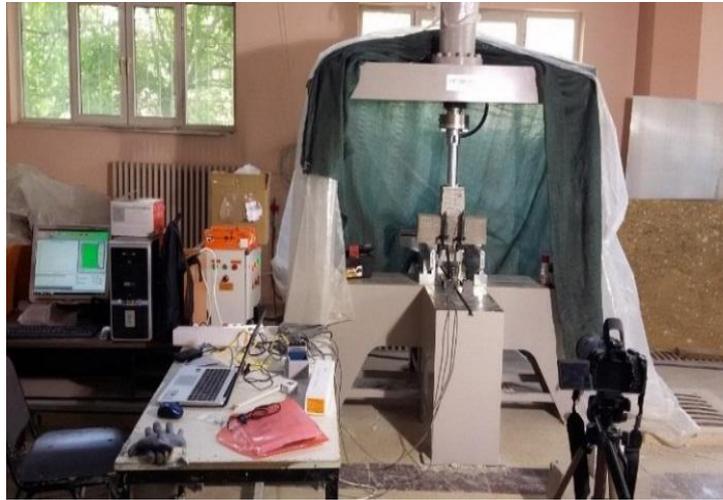
Fig. 6 Corbel setup on the test machine

(150×300) mm according to ASTM C39 specification. All corbels before and after the rehabilitation were tested under a three-point load (Fig. 1). The maximum load capacity of the machine used was 500 kN. The loading rate displacement controlled (0.2 mm/min), the datasets were recorded every 0.2 s. Two LVDTs were used to record the deflections of corbels as shown in Fig. 6.

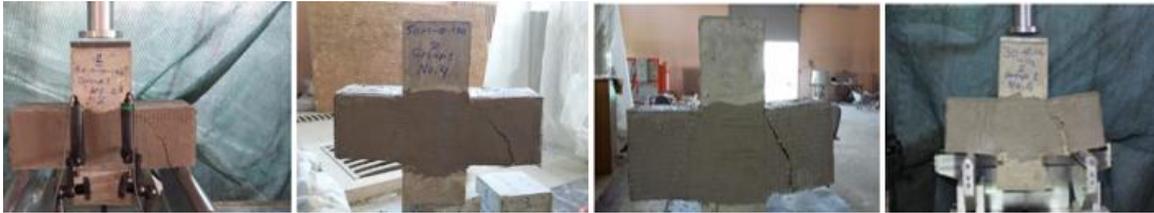
Fig. 8 The mode of failure in the Basalt Fiber Mesh (Rupture in the Fibers)

The failure modes of the corbels before and after rehabilitation are summarized in Table 8. The modes of failure for the corbels before the rehabilitation; flexural failure, shear failure, flexural/shear failure and diagonal splitting failure (Fattuhi 1990). Obviously, the mode of failure after rehabilitation was simply ruptured in the BFM for all corbels and no other type of a failure like a de-bonding failure was observed in the BFM. This type of failure (rupture in the BFM) was a most significant and interesting outcome of this study. Fig. 8 shows the failure in BFM after being tested for four selected corbels, which is occurred in all samples of part one of first group. Moreover, summary of all results of the corresponding corbels were given in Appendix part (Table A1).

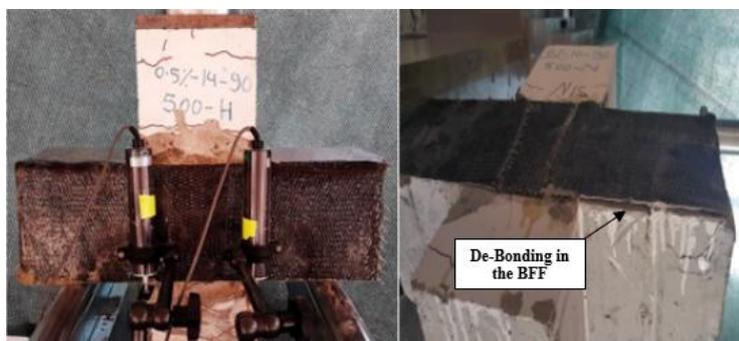
Fig. 13 BFF-strengthened specimen with de-bonding failure

are damaged due to either fire or overloading. All of corbels were covered with unidirectional BFF in two directions, this operation makes the fabric to possess much more strength as compared to adhesive epoxy resin. Therefore, all of the failure modes were a de-bonding failure which occurred between the BFF and concrete surface (see Fig. 13).
