Rehabilitation of corroded circular hollow sectional steel beam by CFRP patch

Mahdi Razavi Setvati^a and Zahiraniza Mustafa*

Department of Civil and Environmental Engineering, Universiti Teknologi PETRONAS, 32610 Seri Iskandar, Perak, Malaysia

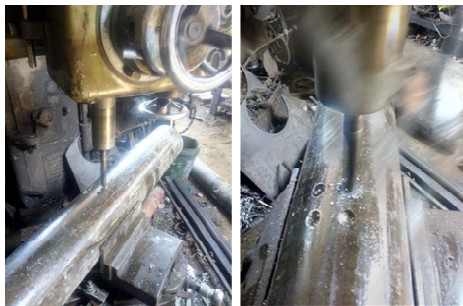
Fig. 2 Corrosion damage creation

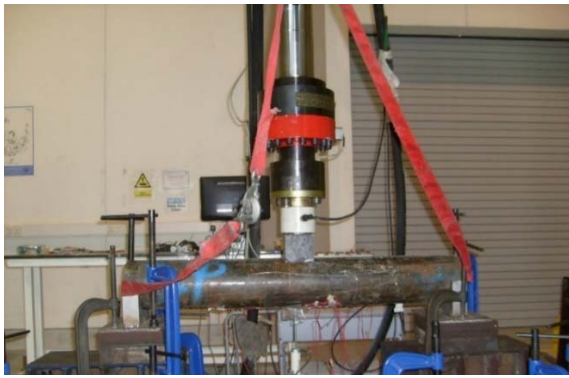
Fig. 5 Three-point bending test

The specimens were subjected to three-point bending under static load conditions, as shown in Fig. 5. Such a testing scheme is particularly useful for studying the performance of damaged beams (Yail and Garrett 2011). One linear variable differential transformer (LVDT) was located at the mid span (immediately beneath the applied load) to measure the deflection of the sample. Three KYOWA, 2-mm-long, strain gauges were mounted on the surface of the CFRP patch to measure longitudinal strains of the composite repair. Fig. 6 shows the positions of the strain gauges on the experimental samples. The load, midspan deflection, and strains at different points were recorded with a data acquisition system interfacing with a PC.

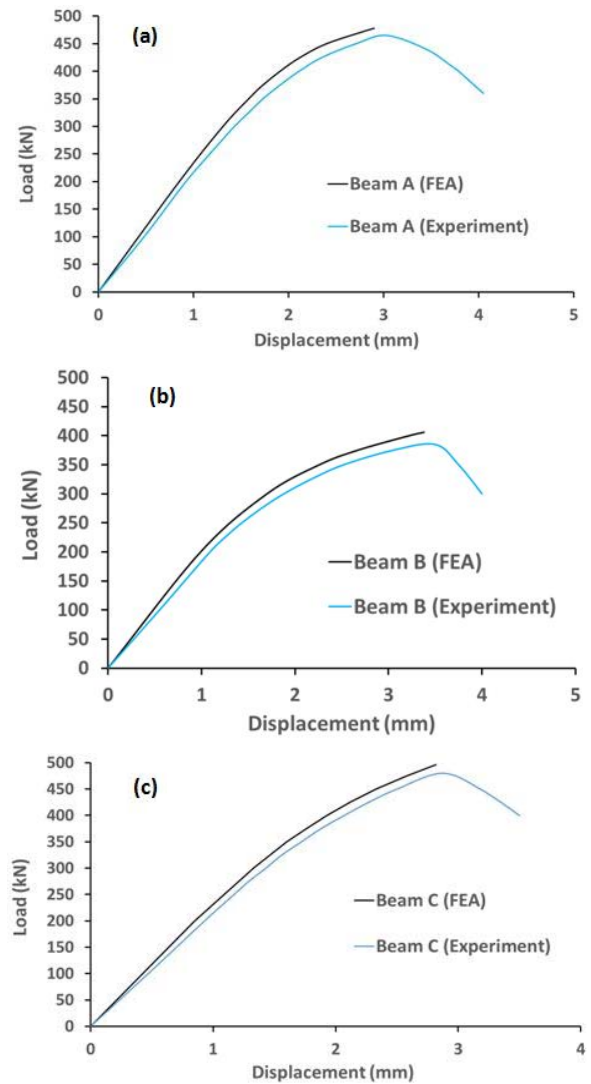
Figs. 12(a)-(c) show the midspan load-displacement responses of the predicted and experimental Beams A, B and C, respectively. These figures indicate that the predicted load-displacement response agreed well with that measured experimentally with average error of 8.9%. Experimental uncertainty, such as thickness of adhesive in a wet layup application, and assumptions in FEA, such as bilinear model of steel, could have contributed to the discrepancy.

Fig. 12 Load-displacement response of (a) Beam A; (b) Beam B and (c) Beam C

The load-displacement curves became nonlinear, mainly because of the steel plasticity, following a linear elastic range. The Beams A and B failed by yielding of steel section, whereas the Beam C failed due to the rupture of CFRP patch, i.e., failure of CFRP in the transverse direction of patch by fiber breaking. This failure constitutes an intralaminar damage as the failure established inside a ply. The yielding of the beams was initiated exactly at the midspan and underneath of the beams, where the maximum strain occurred. Gradual load-softening was observed beyond the ultimate load of the experimental beams.

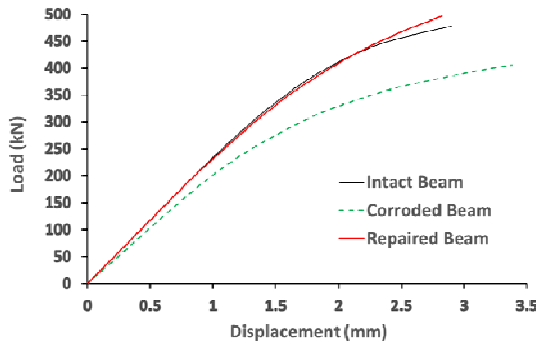
Fig. 13 Comparison of predicted results

Fig. 13 compared load-displacement curves of computational Beams A, B and C. A summary of the predicted elastic stiffness and strength of the beams is given in Table 2. It can be observed that Beam C exhibited an increase in stiffness as well as ultimate strength, compared to the corroded beam (Beam B). The load-sharing mechanism between the steel and CFRP improved the flexural capacity of the repaired beams. The repair effect was more pronounced in the post-elastic region compared to the elastic region. This finding is consistent with observa-

tions from other studies by Ahmed *et al.* (2015, 2017), who conducted researches on the composite repaired concrete-filled steel tubular (CFST) beams. This finding can be explained by the fact that following yield, and the loss of stiffness of the steel, the contribution of the CFRP repair becomes greater. The elastic stiffness of corroded beam (Beam B) and repaired corroded beam (Beam C) are 204 and 228 kN/mm, respectively, which are 91.1 and 101.8% of that of undamaged beam (224 kN/mm). The flexural strength of corroded beam and repaired corroded beam are 406 and 496 kN, respectively, which are 84.9 and 103.8% of that of undamaged beam (478 kN). Therefore, the corrosion reduced elastic stiffness and flexural strength of the undamaged beam by 8.9 and 15.1%, respectively, and composite repair recovered 10.7 and 18.9% of those, respectively, compared to undamaged beam. These results demonstrated the ability of CFRP patch repair to restore full bending capacity of the corroded CHS steel beam.

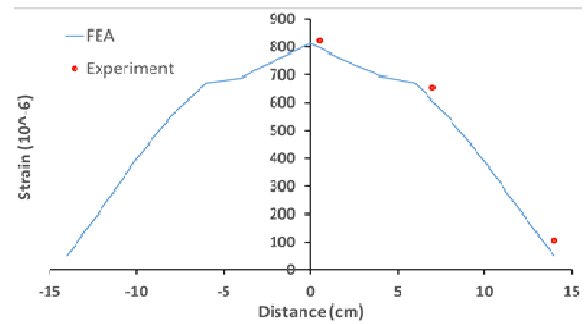
Fig. 14 Longitudinal strain distributions in CFRP patch of Beam C

The longitudinal strain distributions in the composite patch of the repaired corroded beam (Beam C) at a load of 50% P_u (typical service state) was graphed in Fig. 14. The computed strains agreed well with those measured experimentally. A symmetrical non-uniformly distribution shape was observed. The longitudinal strain at mid-span achieved the maximum value because the geometrical discontinuity at corroded region caused stress concentration at mid-span of the beam. The strain value significantly decreased away from mid-span to two terminations of the CFRP patch. It is worth nothing that Chen *et al.* (2015) reported that strains distribute non-uniformly in CFRP plate for nonprestressed specimen, and strains distribute uniformly in CFRP plate for prestressed specimen. Moreover, Chen *et al.* (2015) indicated that prestressed CFRP plate utilization efficiency is better than

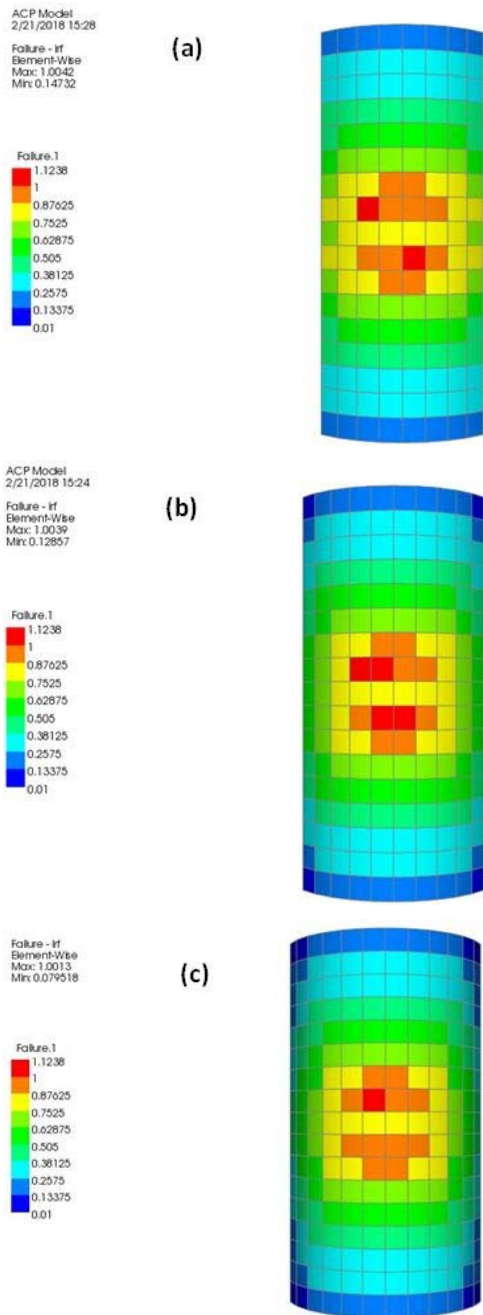
Fig. 19 Failure analysis of repaired beams having CFRP patch widths of (a) 12; (b) 14; and (c) 16 cm

Flexural responses of repaired CHS beams having three CFRP patch widths of 12, 14 and 16 cm were depicted in Fig. 18. It can be seen that CFRP patch width had negligible effect on the stiffness of the repaired beam. This observation can be explained by the fact that increasing CFRP patch width from 12 to 16 cm resulted in adding composite repair near to position of neutral axis of the cross section and, therefore, it has negligible effect on the moment of inertia and flexural stiffness of the beam. Fig. 18 indicates that unlike the stiffness of the repaired beam, the strength recovery was affected significantly by the CFRP patch width. This is because of failure mechanism of the CFRP patch repair. Results of failure analysis of the repaired beams having three CFRP patch widths of 12, 14 and 16 cm are shown in Figs. 19(a)-(c), respectively. The critical failure criteria of the repaired beams are maximum strains in the longitudinal direction of the CHS beam. The critical region is the center of the patch, which is close to the corroded area of the steel beam, because of strain concentration at this position, which resulting from large deformation of the steel beam at this position. Widening the patch includes adding the repair material near the critical region of the CFRP patch repair. The greater amount of repair material at the critical region resulted in ability to carry more load and, therefore, prevented the early failure of composite and increased strength of the repaired beam.

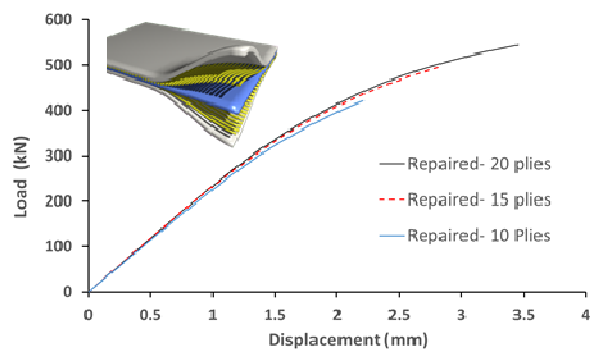
Fig. 20 Effect of number of CFRP plies on the flexural performance of repaired beam

Load-deflection curves of corroded beams having 10, 15, and 20-ply composite repairs were depicted in Fig. 20. It can be noticed that increasing the number of plies (CFRP thickness) enhanced the stiffness of the repaired beam. This is mainly because that thicker CFRP repair resulted in the greater moment of inertia of the cross section and, thus, stiffer beam. It was found that number of CFRP plies has substantial effect on the strength of the repaired beam. This is attributed to the failure mechanism of the repaired beam. Results of failure analysis of the repaired beams having 10, 15 and 20-ply CFRP patch are shown in Figs. 21(a)-(c), respectively. The critical failure criteria of the repaired beams are maximum strains in the longitudinal direction of the CHS beam. Increasing the thickness of the CFRP repair material strengthened it and as a consequence it can stand greater amount of longitudinal strain. This resulted in

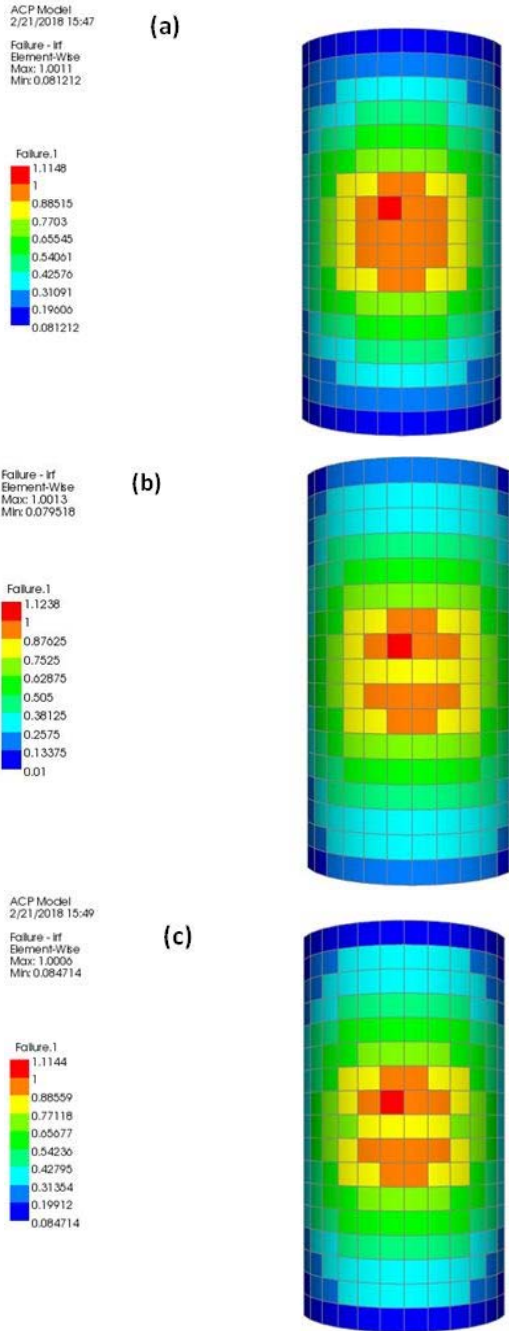
Fig. 21 Failure analysis of repaired beam having (a) 10-ply CFRP; (b) 15-ply CFRP; and (c) 20 ply-CFRP Patch

delaying the failure of composite repair and increasing strength of the repaired beam.

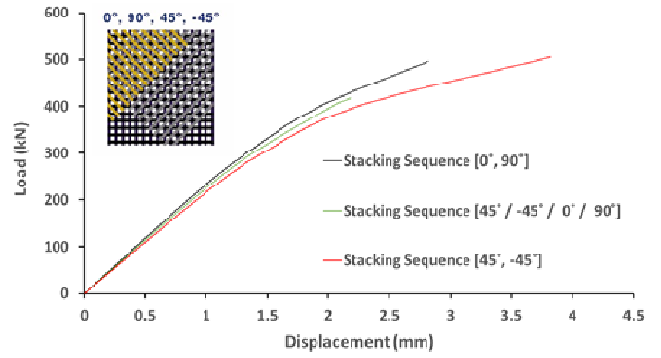
Fig. 22 Effect of stacking sequence on flexural behavior of repaired beam

A summary of flexural behaviors of the repaired beams having three different stacking sequences, including $[0^\circ/+90^\circ]$, $[+45^\circ/-45^\circ/0^\circ/+90^\circ]$ and $[+45^\circ/-45^\circ]$, is given in Fig. 22. These three stacking sequences were commonly observed in the composite applications (Allan *et al.* 2016, Gong *et al.* 2015, Harald *et al.* 2012, Papanikos *et al.* 2005). It can be observed that the repaired beam having stacking sequence of $[0^\circ/+90^\circ]$ showed the highest stiffness

compared to the two other beams. This observation can be explained by the fact that this beam contains the maximum number of 0° layers, whose fiber orientation coincides to the longitudinal direction of the beam, and, therefore, its repair material is the stiffest in this direction, which resulted in the stiffest repaired beam. It can be noticed that repaired beam having stacking sequence of $[+45^\circ/-45^\circ]$ exhibited the highest strength compared to the two other beams. This observation is attributed to the failure mechanism of the repaired beam. Results of failure analysis of the repaired beams having stacking sequences of $[0^\circ/+90^\circ]$, $[+45^\circ/-45^\circ/0^\circ/+90^\circ]$ and $[+45^\circ/-45^\circ]$ are shown in Figs. 23(a)-(c), respectively. The critical failure criteria of the repaired beams are maximum strains in the longitudinal direction of the CHS beam. This beam contains no 90° layer (its fiber orientation is perpendicular to the longitudinal direction of the beam), which is the weakest fiber orientation for this particular beam configuration. This leads to preventing the early failure of repair material and, thus, the greatest strength of the beam. The effectiveness of the patch lay-ups with regard to stiffness and strength enhancement should not be the only criteria for their use as repairs. Other critical parameters, such as thermal expansion, must be also taken into account. For instance, although the quasi-isotropic $[+45^\circ/-45^\circ/0^\circ/+90^\circ]$ did not show the most effective concerning the stiffness and strength improvement of the repaired beam, it is well known that it has smaller thermal expansion than the two other layups.
