# Resilient structures in the seismic retrofitting of RC frames: A case study

**Keywords:** Chevron-type steel bracing; Shear walls; Earthquake reconstruction; Resilient seismic structure; Seismic performance; Performance based design

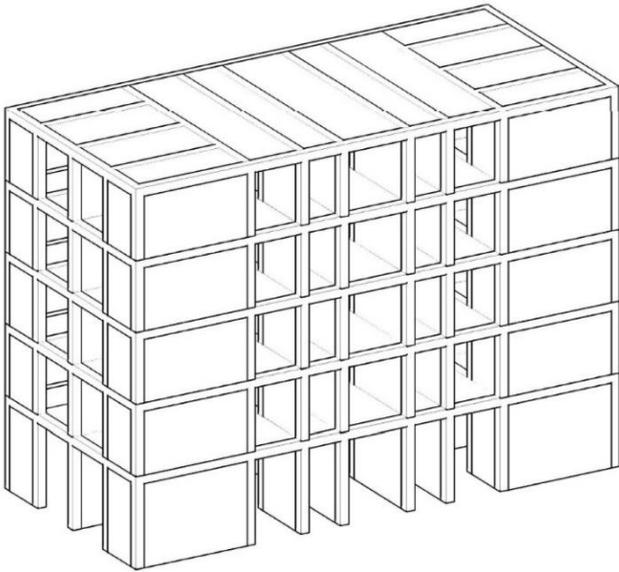
Fig. 3 Model of the 3D structure based on concrete shear walls

such as corridors, staircases etc. Fig. 3 depicts the 3D model used to perform the structural calculations, with base fixed at ground level. All these data and structural scheme are in accordance with the typical seismic Chilean RC building reported by Lagos et al. (2012).

SeismoSoft (2013) software was used for the calculations given in Figs. 3 and 6 in the two main X-Y directions. This software can consider material and geometrical non-linearities in both static and dynamic analyses. For additional information, the reader is referred to the work by D'Aniello et al. (2013), where modelling issues for braced structures are discussed using SeismoSoft. In the present paper, steel material is modelled according to the classic Menegotto-Pinto steel model (Menegotto and Pinto (1973)) with slight modifications to account for higher numerical stability and accuracy for transient seismic loads. Yield strength was established in 500 MPa for rebars and 270 MPa for structural steel, while modulus of elasticity was 2E5 MPa. Concrete material follows the constitutive relationship proposed by Mander et al (1988), considering confinement effects due to lateral transverse reinforcement and cycle rules stated by Martinez-Rueda and Elnashai (1997). This five-parameter model was defined providing mean compressive strength (25000 kPa), mean

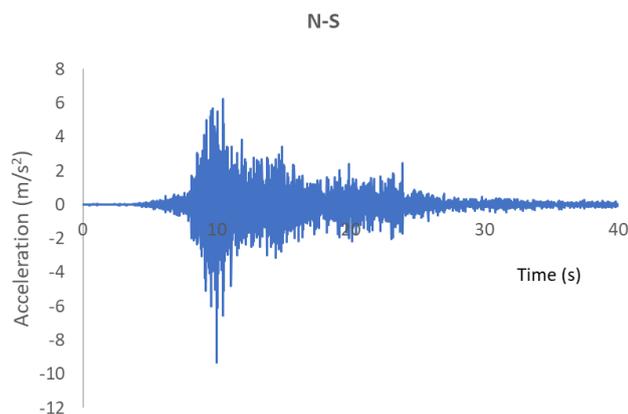
Fig. 4 Accelerations in N-S direction registered in Maule earthquake 2010

The earthquake load was introduced in the form of the actual accelerogram that was registered in the N-S direction (see Fig. 4), and time history analysis were conducted on all the structures under study.

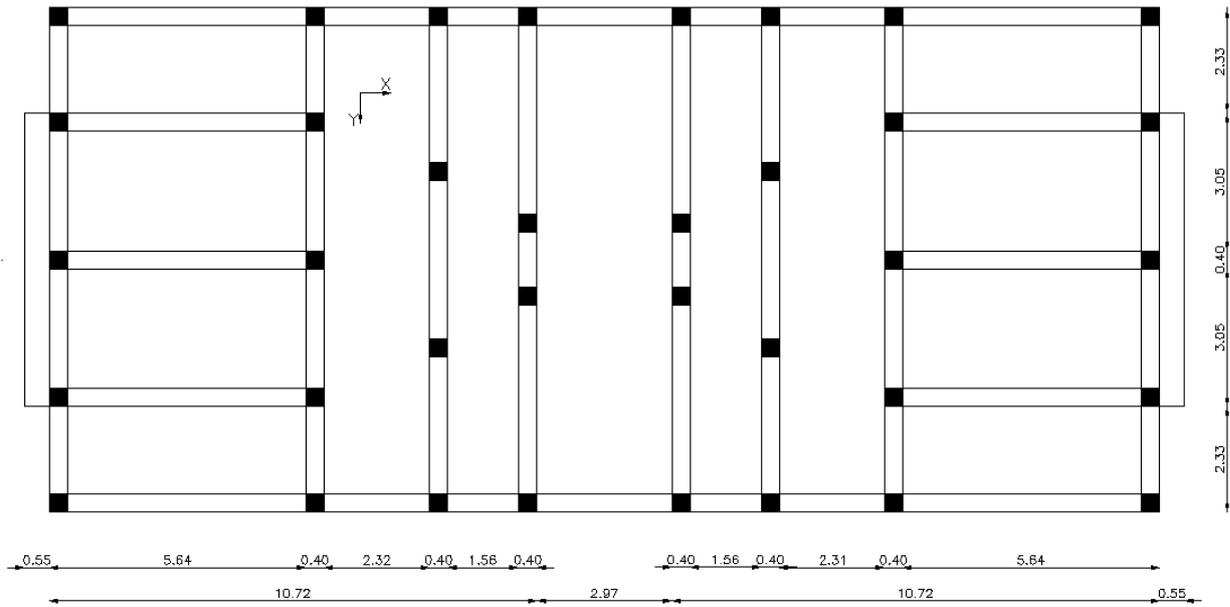
Fig. 5 Plan of beams and columns in the building ground floor of systems a and b (units in m)

Fig. 5 shows a plan view in which the beams and columns are used for the frame system, while Fig. 6 shows the 3D models used to calculate these systems.

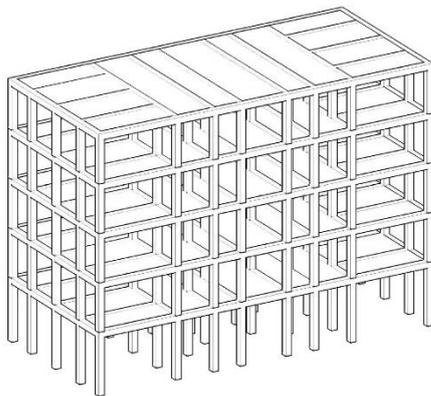
(a) Basic frame system

Fig. 6 Graphical representation of the numerical models

The basic system (Fig. 6a) is formed by 0.40x0.40 m columns on the ground floor and 0.30x0.30 m columns on the upper floors, 0.40Hx0.35V m cross section beams and 0.14 m thick slabs. System b (Fig. 6b) is based on the same structural frame with additional steel braces formed by 200.200.16 mm A250ESP steel beams (NCh203 (2006)). Two chevron-braced systems were installed on each of the outer walls. The concrete characteristics and design specifications were the same as those used for the case study. Correspondingly, models were base fixed at ground level.

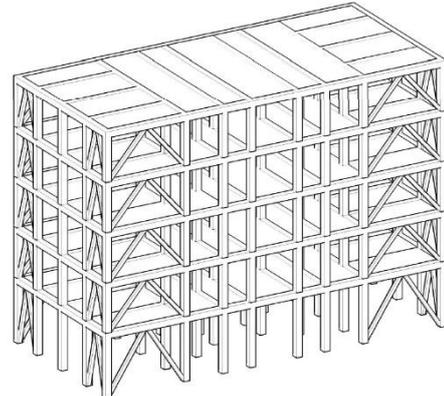
(b) Basic frame system plus steel braces

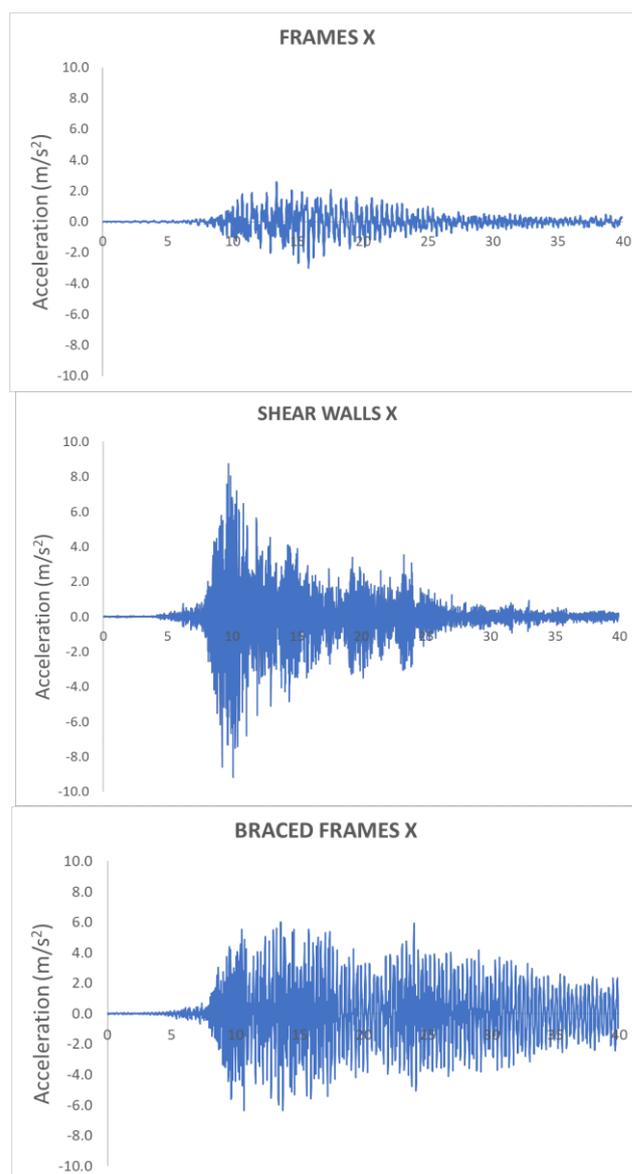
Fig. 7 Accelerations at top floor in N-S (X) direction for Maule earthquake 2010

With the aim to better understand the behavior of the structural systems under study and get a general idea, response accelerograms at the top floor were obtained in the N-S direction for the three cases. Fig. 7 shows these responses, where it is interesting to observe the estimated maximum accelerations in the upper floor and time in which the accelerations exceed a certain threshold. For easier comparison, the positive envelopes of these accelerations are plotted in Fig. 8. The case under study is a very stiff structural system which replicates and amplifies the input accelerogram. A great peak acceleration, amplified from the input one, is withstood by the system at the early stages. Following, the response decays as the earthquake does, although amplifications are found in the whole time range. This amplified maximum acceleration is usually very destructive in this type of structures, inducing strong damage in structural and non-elements, costly to repair, so should be avoided if possible. Designing for this maximum value could overestimate the structure for the rest of the seismic motion. The basic frame system is quite more flexible and the response accelerations at the top are filtered by the structure, obtaining much lower values than the previous case. This could lead to think about a better performance; however, it will be shown that this model leads to excessive displacements that do not accomplish Code provisions. The third system, the braced frame, does not amplify the response at the peak, so reducing the expected damage when compared to the case study. The maximum level of accelerations is approximately maintained for longer period without clear decay, and amplifications are observed when compared to input acceleration. However, if displacements are admissible, designing for the maximum acceleration would not overestimate in excess for the rest of the earthquake.

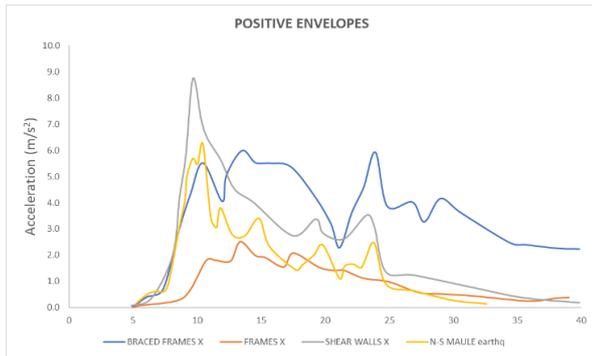
Fig. 8 Positive acceleration envelopes vs time for input earthquake and studied structures

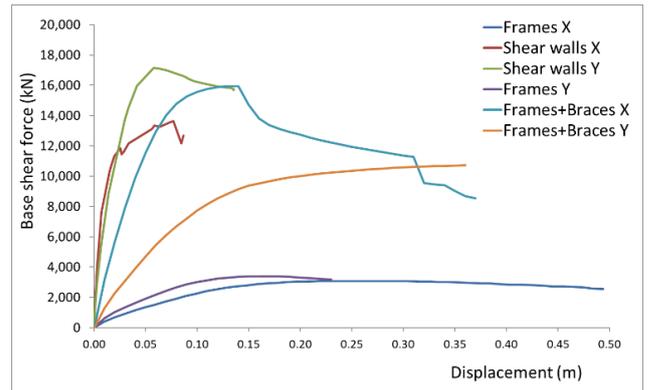
Fig. 9 Base shear force versus horizontal displacement in pushover analyses

The seismic action was obtained in terms of a response spectrum according to NCh433 (2009), adapted following the ASCE (2007) Code, by which the building's performance levels are defined using three states: the Immediate Occupancy limit state, Life Safety limit state and Collapse Prevention limit state. Table 2 gives all these values for the different structural systems, while Fig. 9 shows total base shear force versus horizontal displacement in the X-Y directions at the top of the building for each of the cases under study. As can be observed, only the Braced Frames curve in direction Y is lower than its comparable curve in this direction for shear walls, since the chevron-type braces have a different angle of inclination. It would be structurally easy to raise this curve by changing the brace ends or the number of braces.

It seems clear from Fig. 9 that chevron-braced system is able to provide similar levels of structural stiffness and strength to the current design.

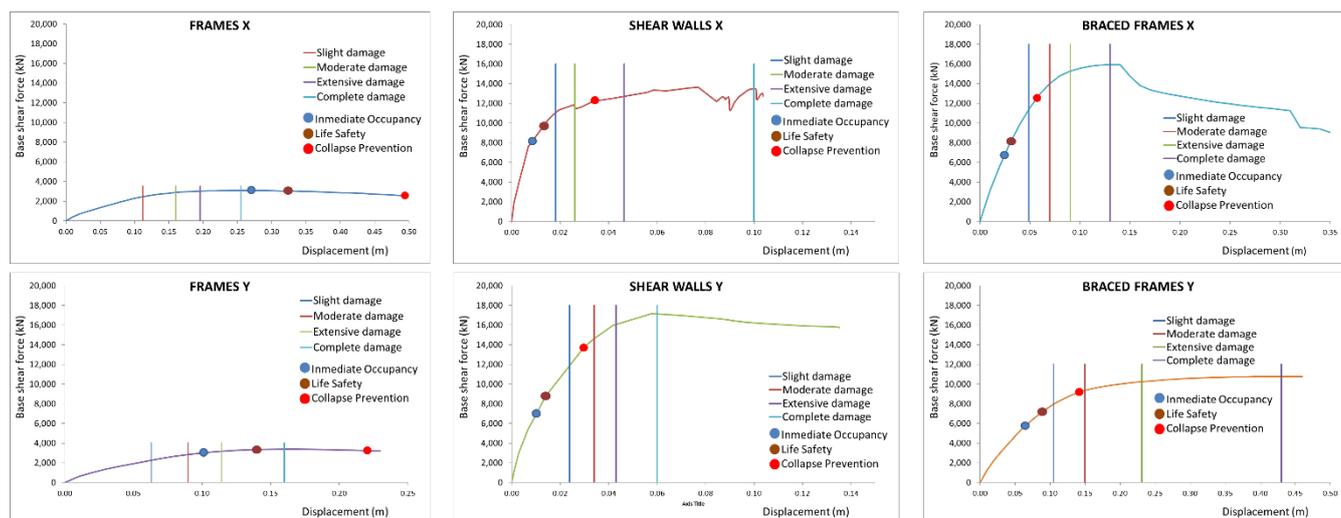
Fig. 10 Damage thresholds and performance levels of all models in each direction

The different structural performance levels can be seen in Fig. 10, together with the damage thresholds. This figure compares the models and shows that the new proposal has better responses than the traditional system.

As expected, the basic framed structure does not provide good results in either direction. The best response (direction Y) causes moderate damage, even for the Immediate Occupancy state, so that this structural model does not meet the seismic demands of the Chilean Standard. More interesting conclusions are obtained when comparing the current shear wall building and chevron-braced frames. In direction Y both systems show almost identical behavior, with performance levels in the same damage states for both cases, even in the 'more flexible' direction Y for the braced frame (see Fig. 9). However, the braced frames show even better behavior in direction X, since the post-earthquake 'Collapse Prevention' state would be in the zone between 'Extensive' and 'Complete' damage for shear walls, while it would be between 'Slight' and 'Moderate' damage for the chevron-braced frame proposal.

Changes in stiffness observed in Fig. 10 for shear walls are due to progression of damage in shear walls, quite pronounced because the large stiffness of every shear walls greatly affects global behavior.
