## Application of self-healing technique to fibre reinforced polymer wind turbine blade

**Abstract.** This paper presents a novel concept of healing some of the damages in wind turbine blades (WTBs) such as cracks and delamination. This is achieved through an inherent functioning autonomous repairing system. Such wind turbine blades have the benefit of reduced maintenance cost and increased operational period. Previous techniques of developing autonomous healing systems uses hollow glass fibres (HGFs) to deliver repairing fluids to damaged sites. HGFs have been reported with some limitations like, failure to fracture, which undermines their further usage. The self-healing technique described in this paper represents an advancement in the engineering of the delivery mechanism of a self-healing system. It is analogous to the HGF system but without the HGFs, which are replaced by multiple hollow channels created within the composite, inherently in the FRP matrix at fabrication. An in-house fabricated NACA 4412 WTB incorporating this array of network hollow channels was damaged in flexure and then autonomously repaired using the vascular channels. The blade was re-tested under flexure

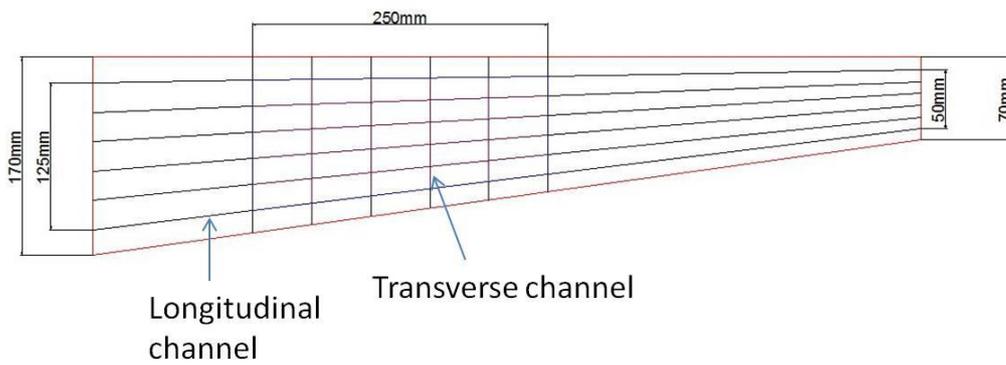
Fig. 1 NACA 4412 WTB 450  $\mu$ m hollow network layout

Some studies (Kim *et al.* 1996, Tay *et al.* 2008) on the progressive failure analysis (PFA) of FRP composites have shown that under a specific loading condition, the most vulnerable layer(s)—the first ply failure (FPF)—within an FRP laminate can be identified. Similarly, results available from some of the few destructive testing on WTBs have been shown that the section, at a third of the blade's length from the root, is susceptible to failure (Shokrieh and Rafiee 2006, Sundaresan *et al.* 1999). Based on these findings, the 2D hollow networks in the GFRP NACA 4412 blade were strategically placed at the 2nd and the 6th layers from both top and bottom of the blade. The network was centred at 230 mm length of the blade from the root, covering an area of 0.025 m<sup>2</sup>. Each level of the multiple hollow networks was formed by connections between six evenly spaced longitudinal hollow spaces and five transverse hollow spaces, Fig. 1. A temporary formwork, in this case a 450 µm diameter nylon cable (fishing line) was used in creating the hollow space. The nylon cable was chosen due to its high loading capacity of 110 N. The cables were extracted after the laminate had cured. The network's coverage is the area enclosed by the intersections of the longitudinal and the transverse channels as shown in Fig. 1.

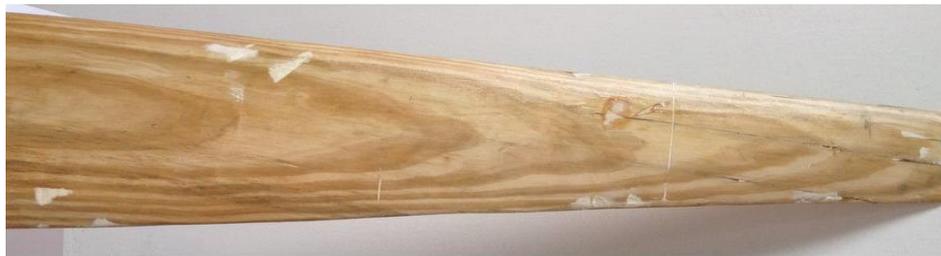
Fig. 2 Wooden NACA 4412 WTB prototype

A wooden blade was made from a piece of softwood, as shown in Fig. 2. A timber block was divided into 14 stations and each division was chiselled down to its appropriate aerofoil NACA 4412 profile. Thereafter, the prototype was placed in a silicon based moulding agent (Mold max-30) on which the top-half of the blade was imprinted. The mould mixture was allowed to cure for 24 hours before the wooden blade was taken out. The edges of the silicon mould were subsequently redressed to enhance workability.

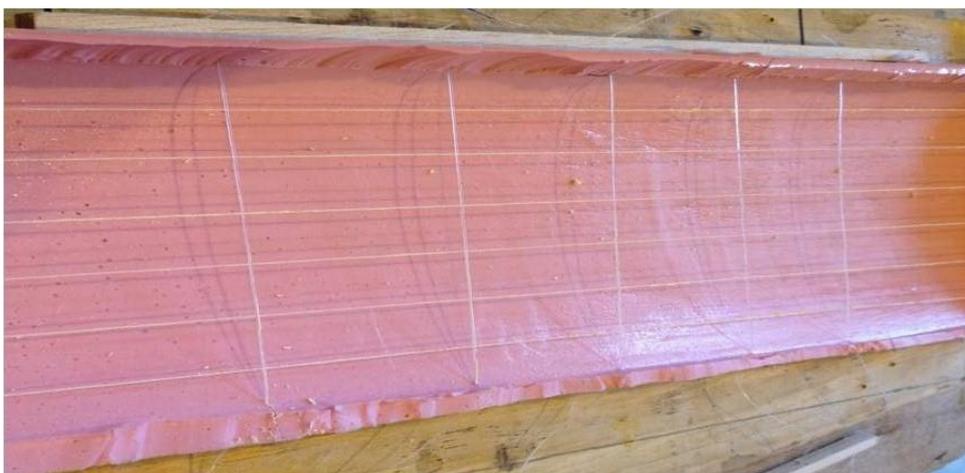
Fig. 3 Slits cut into the mould, holding the 2D network formwork - nylon cables

The silicon mould and the nylon cables were coated extensively with a de-moulding agent to facilitate post curing detachment of the blade from the mould and removal of the nylon wires from the FRP blade. Afterwards, a small volume of freshly prepared polyester matrix was spread evenly on the mould using a paint brush followed by a careful placement of the first layer [0°/90°]. This procedure was repeated for the second layer but with the layer oriented at [±45°]. At this point the nylon cables which had been attached to Balsa wood (at one end), at a specified distance from one another were placed on the matrix-soaked glass fibre clothing. The wires were held in position via slits cut into the mould at the appropriate positions as shown in Fig. 3 and Balsa wood pegs were used to apply and hold tension. The layering process was then resumed along with the appropriate fibre orientations. The process was only stopped briefly for the placement of the nylon cables on the 6th, 9th, and 13th layer. The blade was allowed to cure for 24 hours in the mould at room

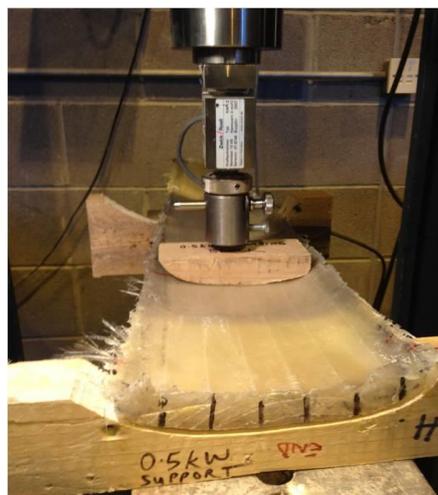
Fig. 4 Set up: Flexural testing of NACA 4412 WT B

The flexural bending test was carried out on the blade using a Zwick Roell 1474 test machine. The set-up is as shown in Fig. 4. The test was conducted in displacement control mode at a rate of 2 mm/min using a 10 kN load cell. The maximum load limit and extension were set to 2 kN and 30 mm respectively. The automatic shutdown threshold was adjusted to 50% drop in the peak load. The test was conducted such that the load was held on following the termination of the test. The blade was simply supported at the root and at 57% of its length by two timber frames with a 300 mm span. This arrangement allows the third-length of the blade from the root, which is covered by hollow network to be specifically tested. The wooden blocks were sculptured to fit the blade's cross-sectional profile at their respective positions. This arrangement enabled the loading head of the Zwick Roell to be placed directly above the centre of hollow network passages. The blade was loaded from the inside rather than from the outside (the suction side), Fig. 4. Also in a similar fashion to the supports, a small timber piece was placed at the loading point for load distribution across the blade's width. The blade was trimmed off by 5 mm at the root section to eliminate curvature, which had developed during fabrication to avoid hindering the adhesive passage during repair. The surface exposed following the cut was subsequently cleaned with acetone. All the transverse hollow outlets were not used as the repairing agent's inlet points and were subsequently blocked with a silicon gel.

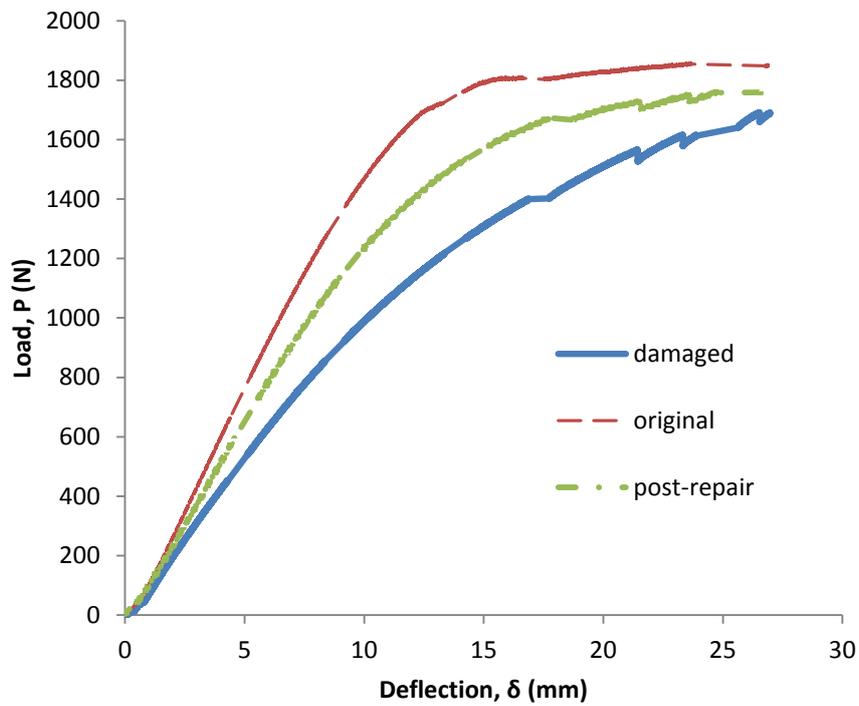
Fig. 5 Post-repair and Initial bending test results on NACA 4412

Furthermore, the deformation around the average peak load of 1800 N of the 'original' plot defines the damage state of the blade in Fig. 5. The change in the normally expected flexural failure mode from sudden load drop to less brittle non-linear deformation in the plot can be attributed to the manner in which the load was being distributed. There was no flexural failure observed which would lead to failure of the bottom layers first. The timber block employed allowed the load to be further spread around it. Consequently, this led to the delamination around the weaker region of the blade near the loading timber and the trailing edge (Fig. 7). The failure cause is not definitive but can be attributed to a wider spread of stress at the loading point and the presence of the hollow network. Also, the asymmetric geometry of the blade may have contributed to this damage due to the stiffness discontinuity.

The post-repair mechanical test response of the NACA 4412 blade is shown in Fig. 5. This figure clearly demonstrates the influence of the CA adhesive in aiding considerable recovery of the blade's stiffness. The flexural stiffness of the repaired blade within the elastic region (between 100-700 N) revealed a stiffness recovery of approximately  $72 \text{ Nm}^2$ . This stands at approximately 84% of the initial flexural stiffness. The recovered efficiency and the comparison plots in Fig. 5

indicate that the adhesive was solely responsible for the linear portion of the 'post-repair' plot. Beyond the elastic region, the adhesive's bond strength dwindles as the blade gradually reverted to its normal non-linear damaged behaviour.

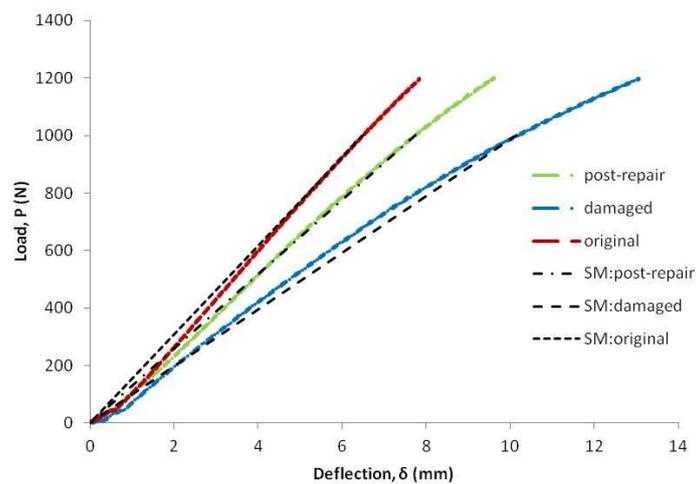
Fig. 6 Gradient determination using secant method

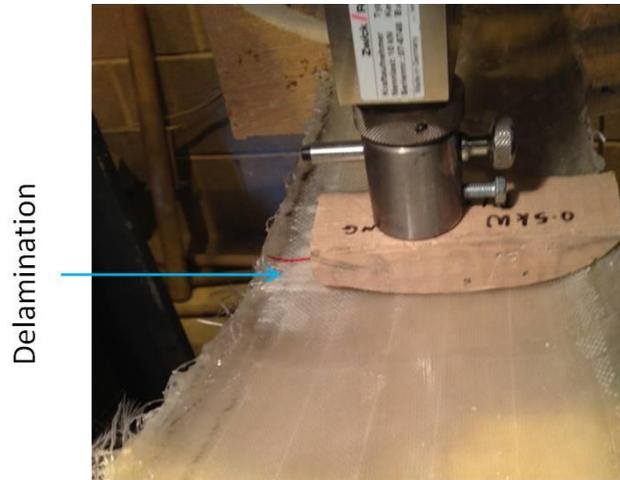
Fig. 7 Delaminatinon around the loading timber

Before the main test, trial runs of the proposed test were conducted to ensure that the blade fits the experimental set-up and that there is no slack leading to force without deformation. The immediate post-test visual examination following the damaged confirmation test, revealed a delaminated area (Fig. 7), near the loading head of the testing apparatus. This damage is located between the second and third layer below the loading head. This is attributed to the presence of the hollow network not matching the curved profile of the layers. As a result, more resin was used in the fabrication process, which created a weakened section between the layers. The load-deflection plots for all the different cases are presented in Fig. 5. The 'original' plot shows the blade's behaviour from its elastic range to failure stage indicated by the apparent non-linear deformation in between 8 mm and 25 mm. The other plot, 'damaged', confirms that the blade has been damaged. The curve

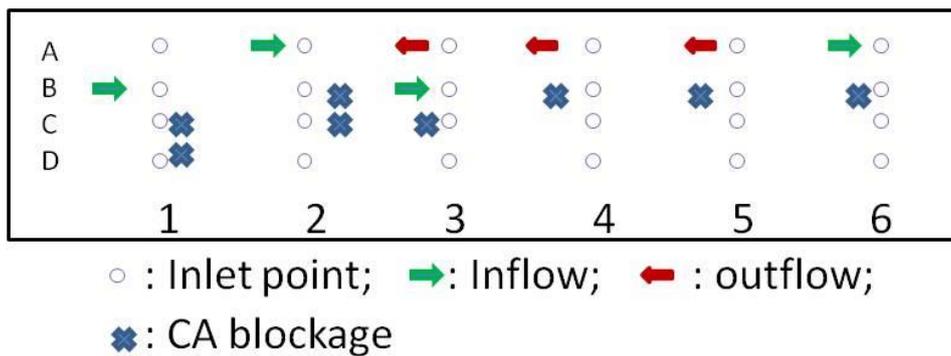
Fig. 8 Schematic illustration of the injecting point at the blade's root

A total volume of 5.5 ml of the cyanoacrylate adhesive was manually injected into the blade while the load was still held on it. The load was taken off after the adhesive injection had been completed. The influx of the adhesive was started from the first injection point, in the second column near the trailing edge. This was to enable the adhesive a short travel route to the delaminated site. Droplets of the adhesive were observed at the nearest previously sealed transverse hollow section in the adhesive's path. This confirms that both the transversely and longitudinally oriented hollow sections were well connected and that the transverse hollow passages were not sufficiently sealed by the silicone sealant. Also, outward seepage of the adhesive was observed at the neighbouring injection points. The adhesive quickly covered a large area of the injecting surface making it difficult to locate some of the inlet points. Due to this, the majority of the holes were not used. Also, while attempting to locate unblocked injection points, the adhesive was noticed to have cured inside some of the syringe needles and on the injecting surface. Fig. 8 shows a schematic representation of the inlets at the blade's root. Furthermore, outflow of the cyanoacrylate adhesive was noted at the blade's tip. Traces of the outflow path were observed on the blade from the tip to the mid section where the blade was being loaded, Fig. 9.

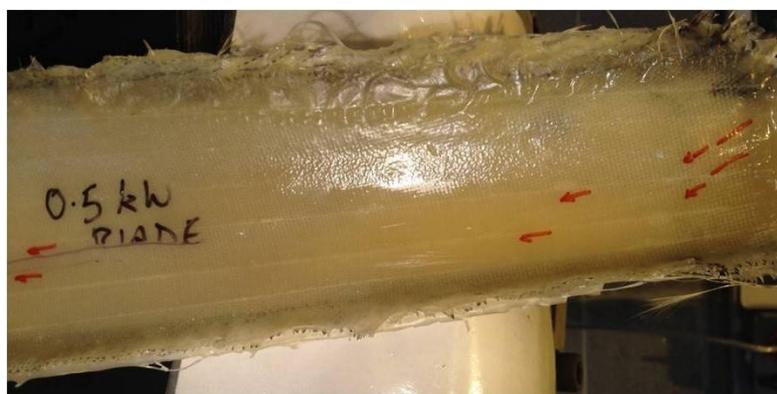
Fig. 9 The cyanoacrylate adhesive's flow path from the blade's tip

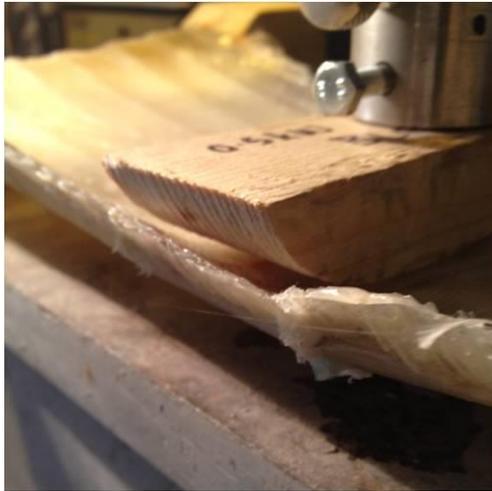
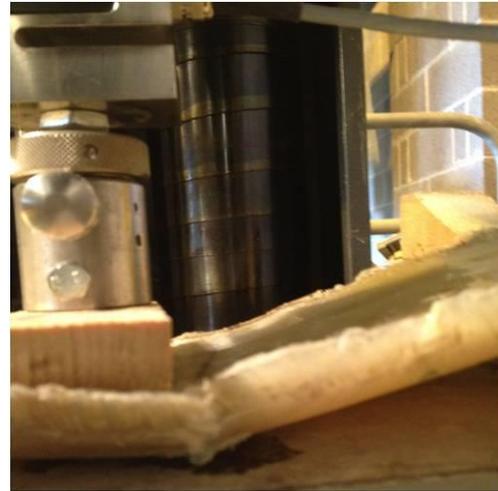
(a) Damaged edge

(b) Closer view of the damage with an outflow of the healing agent

Fig. 10 Underside cut on NACA 4412 and the tilting effect

Close to concluding the 'damaged' test run, there was a sudden increase in load due to the maximum deflected part of the blade at the loading point making contact with the steel base on which the wooden side supports were placed. This led to a 15 mm cut on the underside of blade near the loading timber, Fig. 10a. The cut was at the leading edge and also led to a significant bending which tilted up the blade's tip. Outflow of the adhesive was also noted at this damaged site.

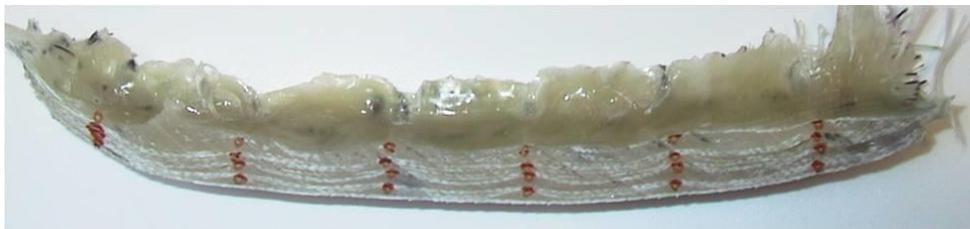
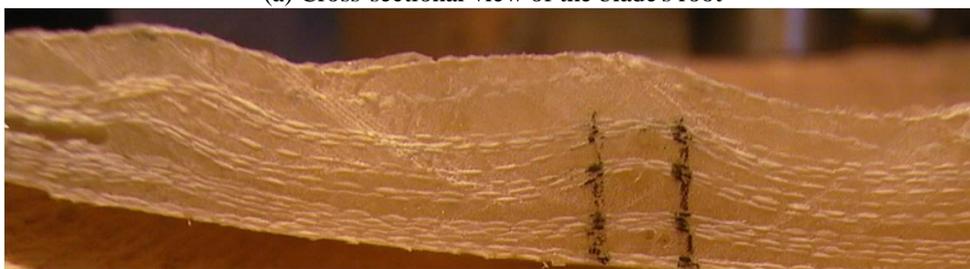
(a) Cross-sectional view of the blade's root

(b) Enlarge view of the of the curvatures

Fig. 11 Curvature and imbalance resin volume across the width and depth

The results provide validation of the concept that a complex WTB structure can accommodate a self-healing system. The NACA 4412 WTB was the first of its kind to be fabricated with an embedded self-healing system and therefore it was expected to possess some flaws. A cross-section at the blade's root revealed an imbalanced resin concentration across the width and depth of the section, especially after each placement of the nylon cables (Fig. 11). Also, the figure shows curvatures around the nylon cables. These curvatures can be attributed as one of the factors that led to the delamination on the blade around the loading area. Under this current self-healing technique, curvature around the hollow sections will be inevitable but should be minimised. Generally, the fabrication process can be improved, using a prefabricated casing that allows the hollow-preforming materials in the transverse direction and those along the edges to be placed at appropriate angles.
