Abstract. The objective of this paper is to report on a study of the use of unstiffened thin steel plate shear walls (SPSWs) for the seismic performance improvement of reinforced concrete frames with deficient lateral rigidity. The behaviour of reinforced concrete frames during seismic activities was rehabilitated with an alternative and occupant-friendly retrofitting scheme. The study involved tests of eight 1/3 scale, one bay, two storey test specimens under cyclic quasi-static lateral loadings. The first specimen, tested in previous test program, was a reference specimen, and in seven other specimens, steel infill plates were used to replace the conventional infill brick or the concrete panels. The identification of the load-deformation characteristics, the determination of the level of improvement in the overall strength, and the elastic post-buckling stiffness were the main issues investigated during the quasi-static test program. With the introduction of the SPSWs, it was observed that the strength, stiffness and energy absorption capacities were significantly improved. It was also observed that the experimental hysteresis curves were stable, and the composite systems showed

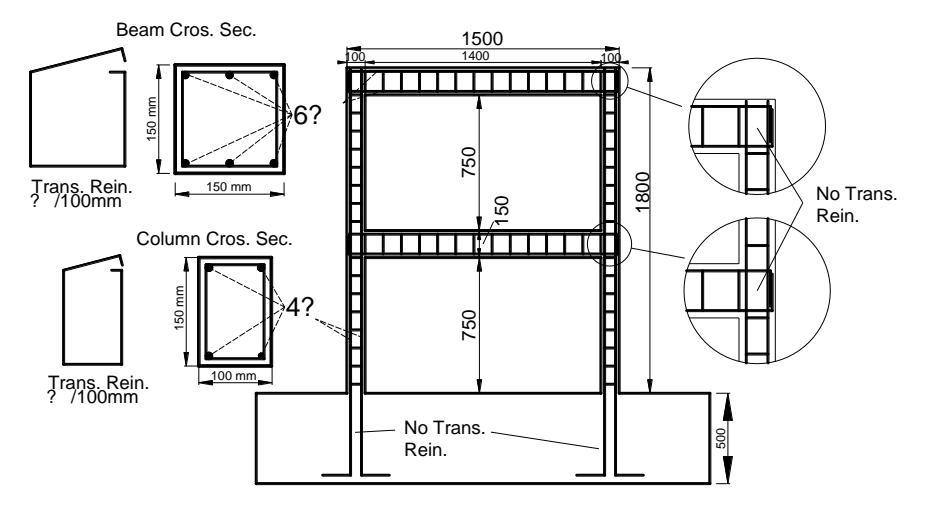
Fig. 1 Dimensions and reinforcement details of test specimens

Total height of the specimens was 1800 mm. The width of the test frame was 1400 mm between the centerlines of the columns. The columns and beams had 100×150 mm and 150×150 mm gross cross sectional dimensions, respectively. Fig. 1 shows the dimensions and design details of the specimens.

Four, 8 mm diameter deformed longitudinal bars were used in columns with a steel ratio of 1.34%. The ends of longitudinal column bars were bent 90° inside the footing. Six 8 mm diameter deformed bars were used in the beams (reinforcement ratio=1.34%. The uniform vertical spacing of 6 mm diameter plain column ties was 100 mm. The 90 degree end hooks of the columns ties were anchored inside the cover concrete to represent a common seismically deficient reinforcement detailing practice. The thickness of the cover concrete was chosen as 8 mm.

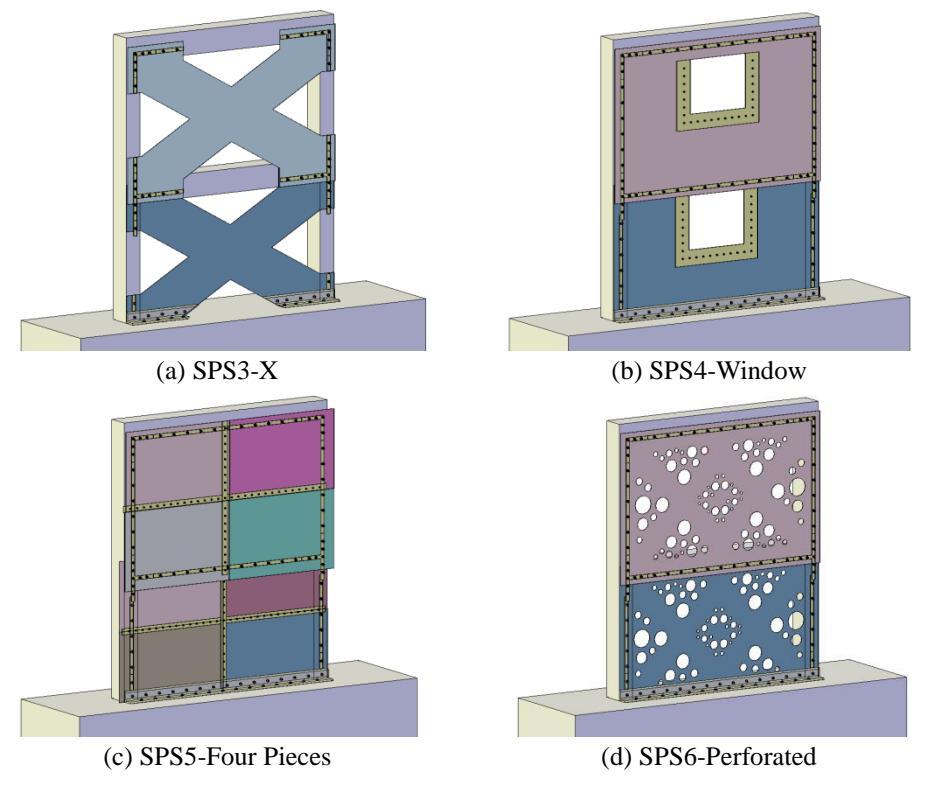
Fig. 3 Schematic illustrations of test specimens

The third specimen, which was named SPS3-X, included X-shaped steel plates (Fig. 3(a)). The objective for

It can be assumed that a full-scale building frame will have a typical bay or opening approximately 5000 mm long and 3000 mm tall. A typical commercial steel plate with 2500 mm×1300 mm dimensions is not large enough to cover or enclose one bay or opening. Therefore, for a fullscale frame, the designer may need to use four or more steel plates to cover one frame opening in one story. Consequently, in the fifth test specimen (SPS5-Four pieces) four steel plates were connected to enclose external surface of one frame opening. The steel plate pieces were attached to each other with 6 mm diameter bolts at a uniform 50 mm interval as shown in Fig. 3(c).

In the sixth specimen, the steel plates were perforated to create several different size circles. This created an aesthetically pleasing appearance while increasing the lateral strength and stiffness of the frame. One major reason for using the perforated plates was to improve the appearance of the external façade of the structure. It was likely that the circular holes on the perforated plates would decrease the plate's strength as compared to solid steel plate, i.e., the second specimen or SPS2-Full. In the specimen with perforated plates, there is a possibility for the plates to fail before the columns fail. This specimen was named SPS6-Perforated and is schematically illustrated in Fig. 3(d).

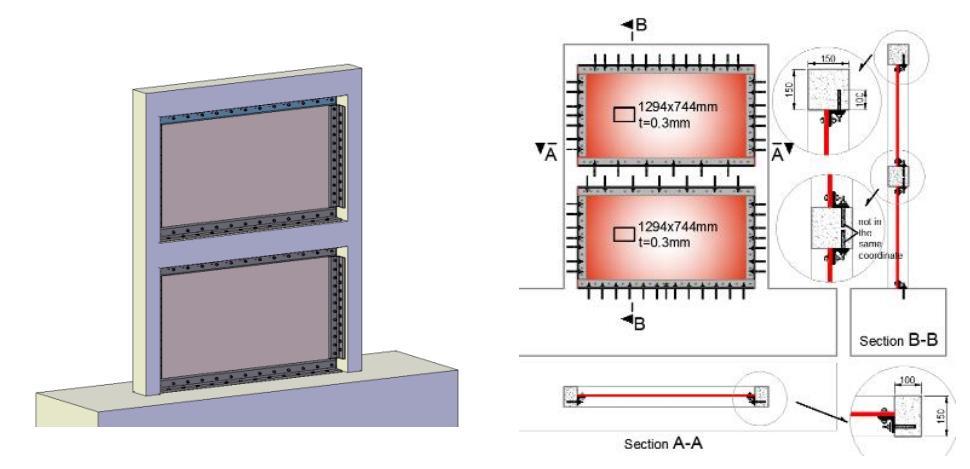
Fig. 4 Test specimen with internal steel plate

In the seventh specimen (SPS7-Inner plate) the steel plates were installed inside the frame instead of the outer face of the frame or façade. The plates were restrained along each of the four edges to create a tension field action inside the plate and to transfer forces to the surrounding beams and columns. The bottom story plate was also anchored to the foundation as in other specimens. Along the edges of the plates, 60 mm×60 mm×6 mm steel angle profiles were used to connect the steel plates to the surrounding RC frame. Steel anchor bolts passing through the steel angles were installed on the RC members (Fig. 4). The anchoring holes for the dowels were 50 mm deep and 8 mm in diameter. In the corners or near the beam-column joints, four holes were drilled at 50 mm intervals. The uniform spacing of the other holes was 100 mm.

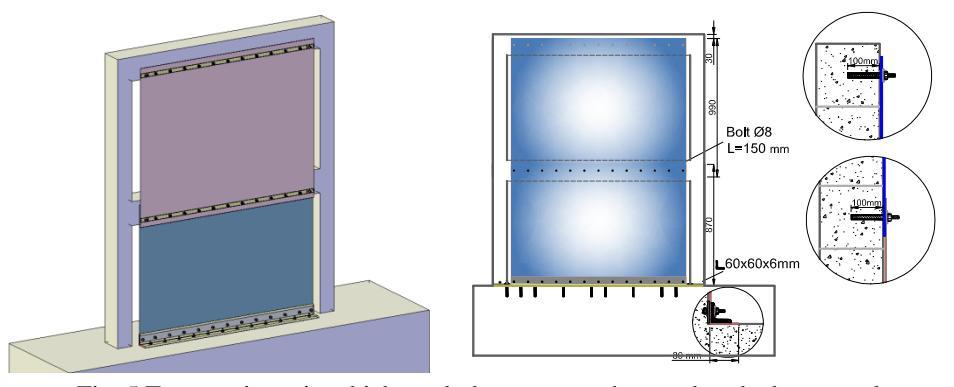
Fig. 5 Test specimen in which steel plate were anchoraged to the beams only

For the last specimen, the steel plates were attached only to the beams. The tension field forces were transferred to beams only (Fig. 5). By doing this, the shear failures of

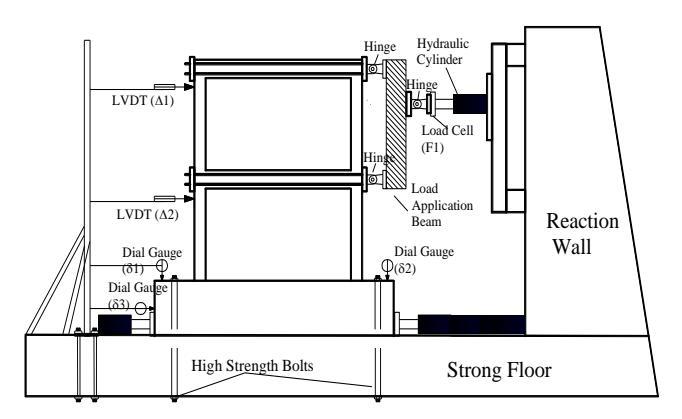
Fig. 6 Representation of the instrumentation scheme

A steel instrumentation frame was used to measure global displacements of the specimens. Dial gauges and LVDTs were installed between the instrumentation frame and specimens. Although the specimens were fixed to the floor of the laboratory, movement of the specimen foundation relative to the strong floor was also monitored using dial gauges. A data acquisition system was used to record the applied load and displacements during the experiments.

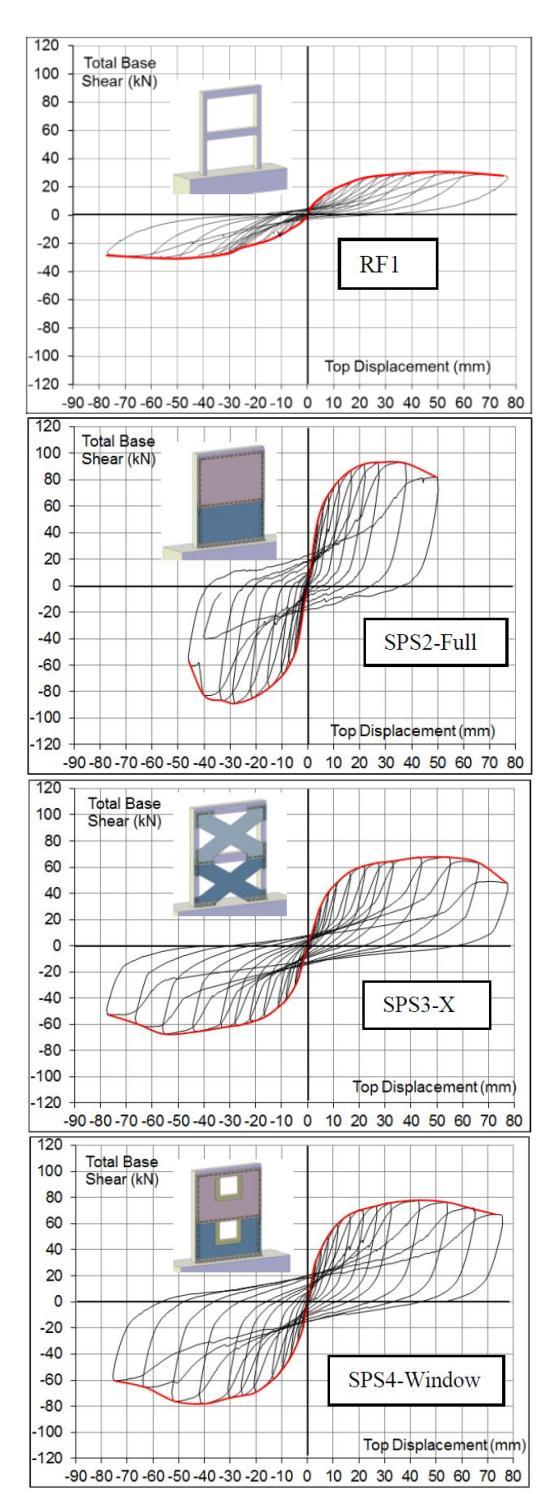
Fig. 7 Measured total lateral load versus displacements (reference specimen and first 3 specimen)

The measured total lateral load or base shear versus top displacement relations for each test specimen were shown in Fig. 7 and Fig. 8. The envelope for the hysteretic response of each specimen is also shown in the Figures (in red). The stiffness, strength, deformation capacity and overall observed behavior of each specimen were discussed

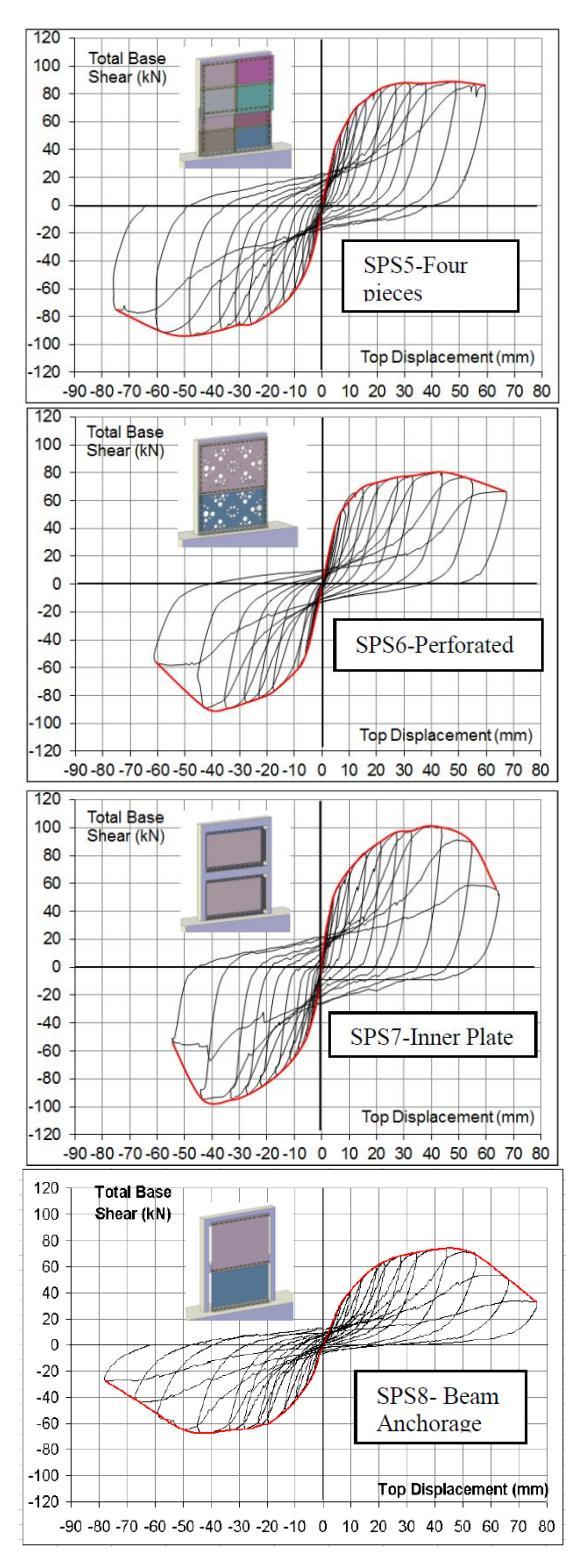
Fig. 8 Measured total lateral load versus displacements (last 4 specimen)

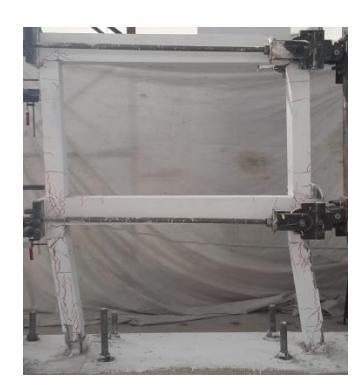
Fig. 9 Overall appearence of specimen RF1 at the end of the test

corresponding top displacements were 44 and 41 mm for the forward backward cycles, respectively. The relative story drifts corresponding to the ultimate load levels, were approximately 2% and 3% for the first and second stories, respectively. The larger drift measured in the first story indicates that the damage was concentrated more in the first story. In fact, the reference specimen (RF1) lost a significant part of its lateral load carrying capacity and failed after formation of plastic hinges in the first story columns. The final failure was dominated by combined flexural and shear damage both in columns and beamcolumn joints (Fig. 9).

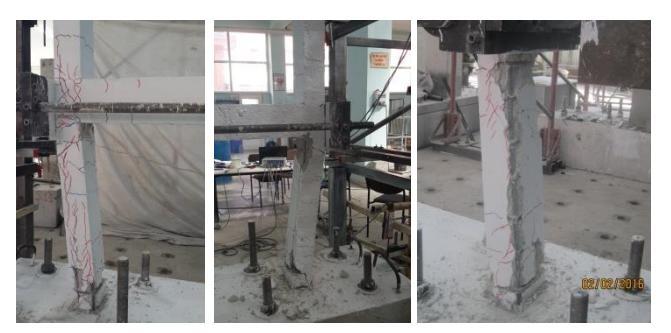
Fig. 10 Specimen RF1 and observed cracks and damage at the end of the test

During the final loading cycles, a sudden drop (up to approximately 31% reduction) in the load carrying capacity was observed in both directions. During these cycles, i.e., the cycles before the last cycle, the top displacement of the specimen was 67 mm. The corresponding maximum relative story drifts during this cycle were 2.8% and 5.4% in the second and first stories, respectively. Figs. 9-10 shows the specimen at the end of the test, including the crack pattern on each side of frame. As discussed above, the cracking and damage was mostly concentrated in the first story while less damage and cracks were observed in the second story.

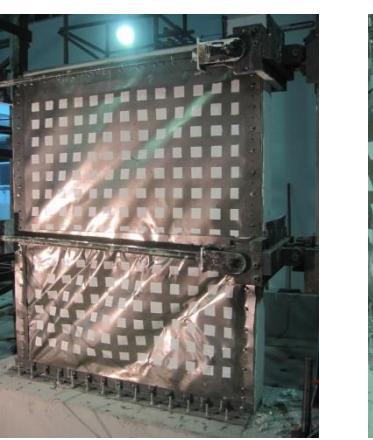
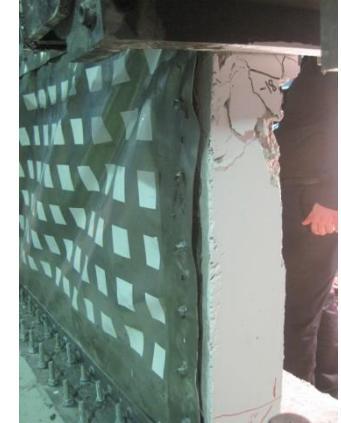
Fig. 11 View of specimen SPS2-Full at the end of the test

As can be observed from Figs. 11 through 17, the steel plates typically buckled and inclined (approximately 45°

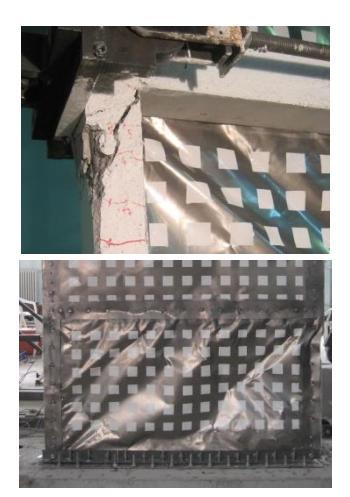
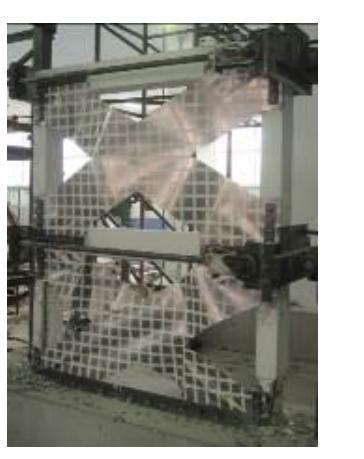
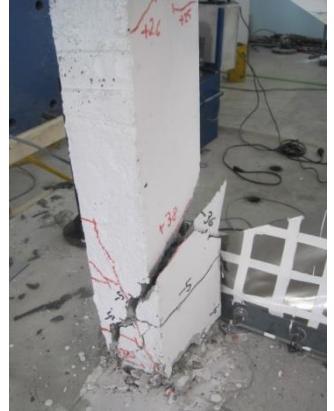
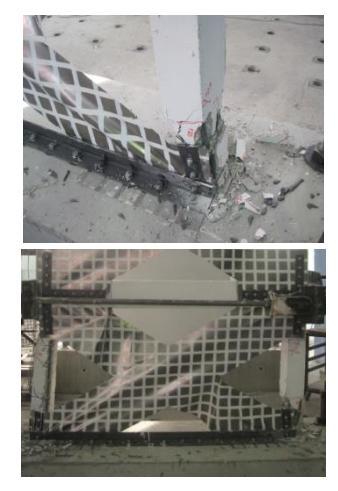
Fig. 12 View of specimen SPS3-X at the end of the test

In the specimens SPS3-X and SPS4-Window, the steel plates were fractured and torn around the sharp corners of the openings. Similar plate tearing was also observed around the circular perforations of the specimen SPS6-Perforated near the end of the experiment.

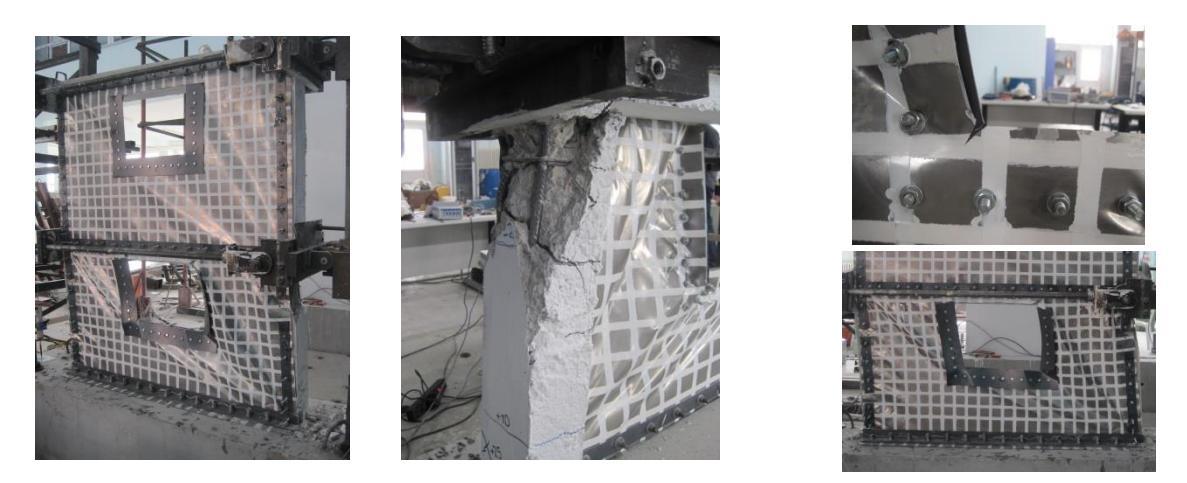
Fig. 13 View of specimen SPS4-Window at the end of the test

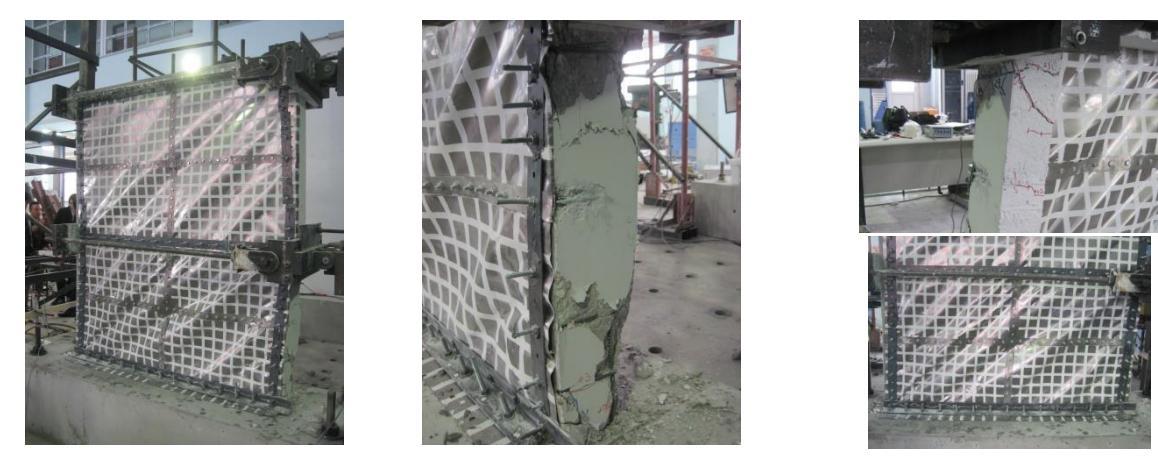
Fig. 14 View of specimen SPS5-Four Pieces at the end of the test

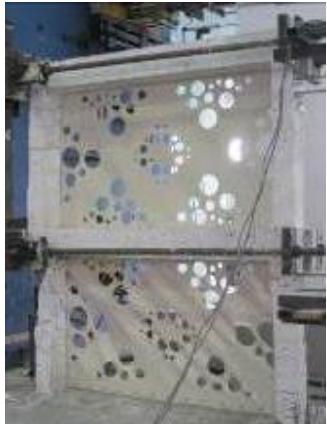
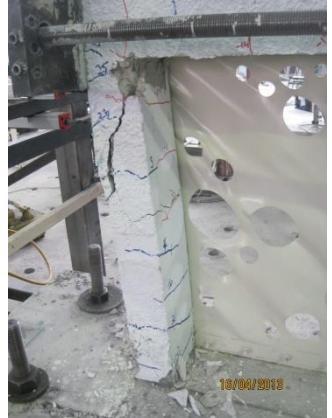
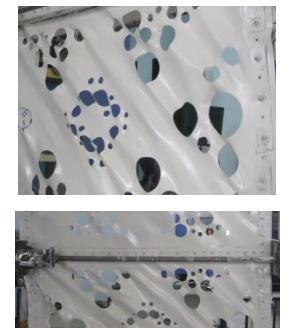
Fig. 15 View of specimenSPS6-Perforated at the end of the test

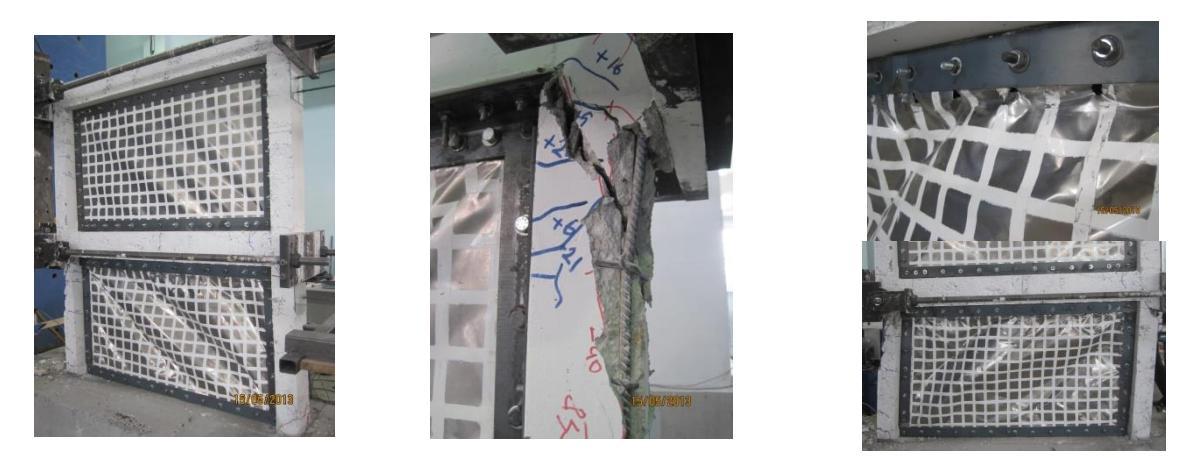
Fig. 16 View of specimen SPS7-Inner Plate at the end of the test

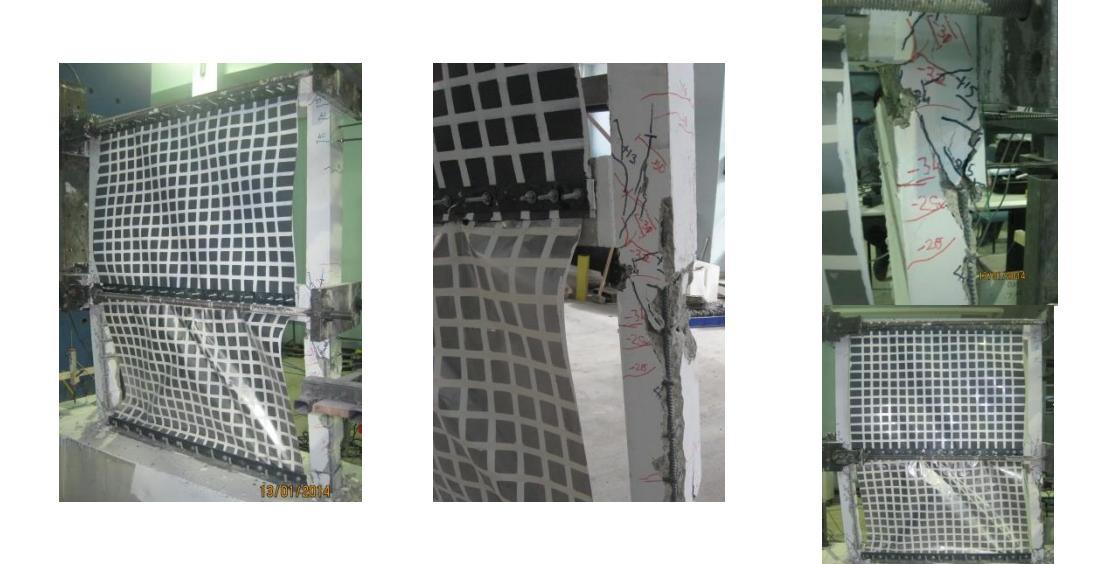
Fig. 17 View of specimen SPS8-Only Beam Anchorage at the end of the tests

The stiffness performance of specimen **SPS8-Beam Anchorage**, was found to be worst among all the strengthened specimens.

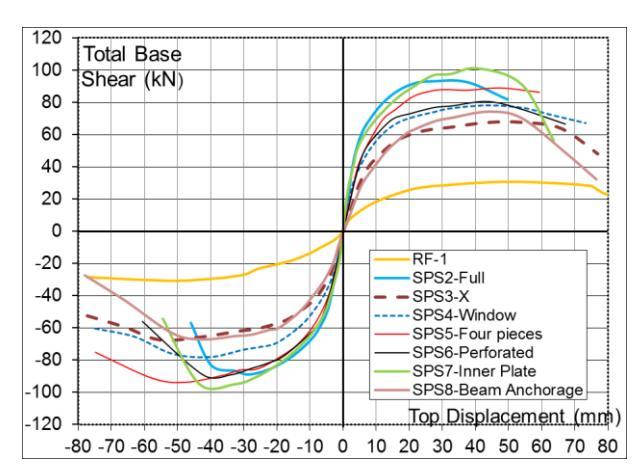
Fig. 18 Measured lateral load-displacement envelope curves for all specimens

To evaluate the efficiency of the applied strengthening methods, the strength and stiffness characteristics of the test specimens were discussed with the help of response envelope curves (red lines in Figs. 7-8). The maximum strength values in each hysteretic loop were connected to draw the response envelope curves. These curves were shown in Fig. 18 to compare the strength and stiffness characteristics and overall response of the specimens.

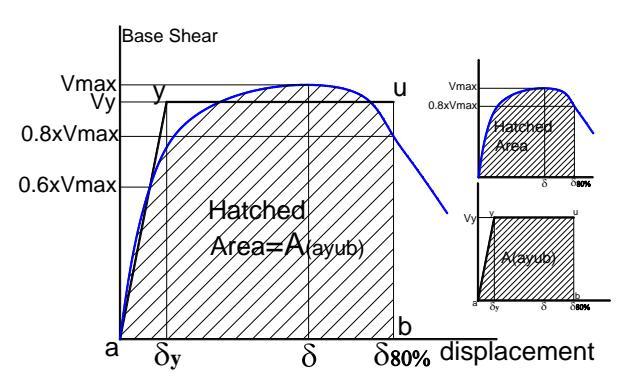
Fig. 19 Bi-linear approximation of the envelope curves

based on an equal area concept was used as shown in Fig. 19. The maximum base shear carried by the system was designated as " V_{max} " (column #1 in the table) and corresponding top displacement was δ (column #2). The elastic portion of the bi-linear curve was assumed to pass through the point at " $0.6 \times V_{max}$ ". The ultimate displacement ($\delta_{80\%}$ -column #3) point was defined as the displacement level corresponding to a 20% decrease in the ultimate lateral load capacity $(0.8 \times V_{max})$. The horizontal portion of the curve was assumed to end at a point of $\delta_{80\%}$. The area under the experimental curve was calculated up to the ultimate point ($\delta_{80\%}$). The yield load (F_v -column # 4) of the bi-linear curve (horizontal portion) was leveled to result in approximately equal gained and lost areas with respect to the original curve up to the ultimate point. The displacement value at the intersection of the linear and horizontal portion was the yield displacement, δ_{y} (column #5) (Dimova and Negro 2005). The ratio between the estimated values of $\delta_{80\%}$ and δ_y was defined as the displacement ductility ($\lambda_d = \delta_{80\%} / \delta_y$) (column #6). Ductility is an important concept as far as earthquake behaviour is

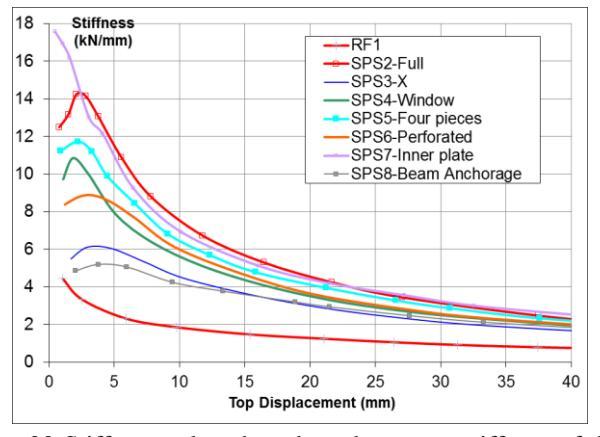
Fig. 20 Stiffness values based on the secant stiffness of the cycles of each displacement increment

The lateral stiffness of the structural system can also be used to evaluate its seismic performance. The stiffness properties of the tested frames were evaluated using their secant stiffness, defined at the peak of each cycle, at each deformation amplitude. The lateral stiffness degradation of the specimens as a result of the cyclic loading was compared. The stiffness values of the specimens were estimated from the forward hysteresis curves and were illustrated in Fig. 20 with respect to the top horizontal displacement. From this curve, the decay in the stiffness can be clearly observed and compared.

Applied SPSWs significantly improved the lateral stiffness of the test specimens. The greatest initial stiffness value was achieved in the specimen SPS7-Inner plate. This specimen exhibited high initial stiffness, and during the following cycles, the stiffness of the frame followed a decreasing trend. On the other hand, the other specimens with external SPSWs had stiffness values in the second or third cycles that were higher than the stiffness values in the first cycle. This is because the stretching of the plates could not be performed properly or could not be conserved during the drilling and fixing operations that occurred during the installation of the external plates. On the other hand, the dimensions of the inner plate were smaller than the frame's inner dimensions. During the fixation of the inner plate, the workers had to apply an extra tensional effect on the plate to fit it to the frame opening.
